Device	XMC1400
Marking/Step	EES-AA, ES-AA, AA
Package	PG-VQFN-40/48/64, PG-LQFP-64, PG-TSSOP-38

Overview

This “Errata Sheet” describes product deviations with respect to the user documentation listed below.

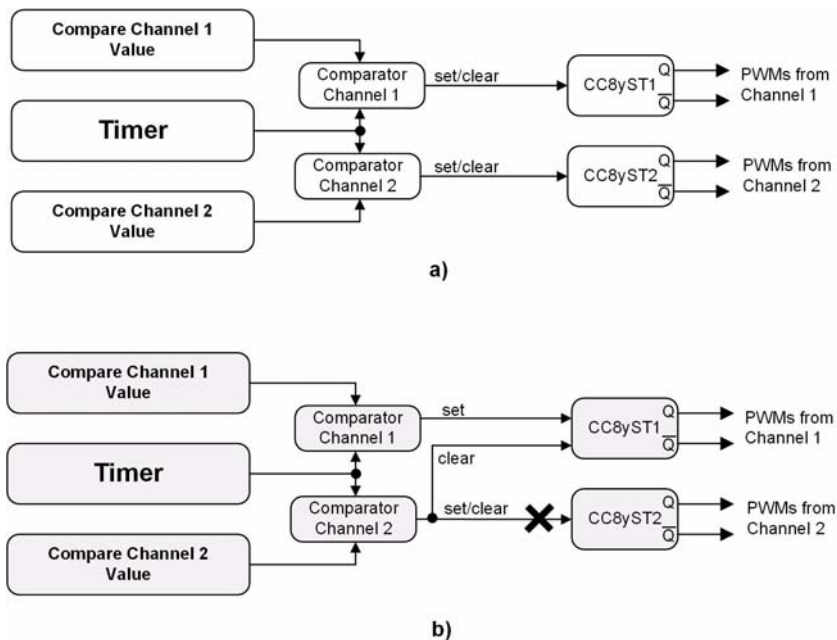
Figure 1 CCU8 simplifier PWM generation scheme - a) normal mode; b) asymmetric mode

CCU8 AI.005 PWM outputs from Compare Channel 2 are disabled in asymmetric mode

The asymmetric mode has a bug, where the PWM signal of Compare Channel 2 is not stored in CC8yST2. This means that from the Compare Channel 2 the timer cannot generate any PWM signal - depicted by the cross on **Figure 1 b)**.

None
