Device	XMC4400
Marking/Step	ES-AB, AB
Package	PG-LQFP-64/100

Document ID is **084/18**.

This “Errata Sheet” describes product deviations with respect to the user documentation listed below.

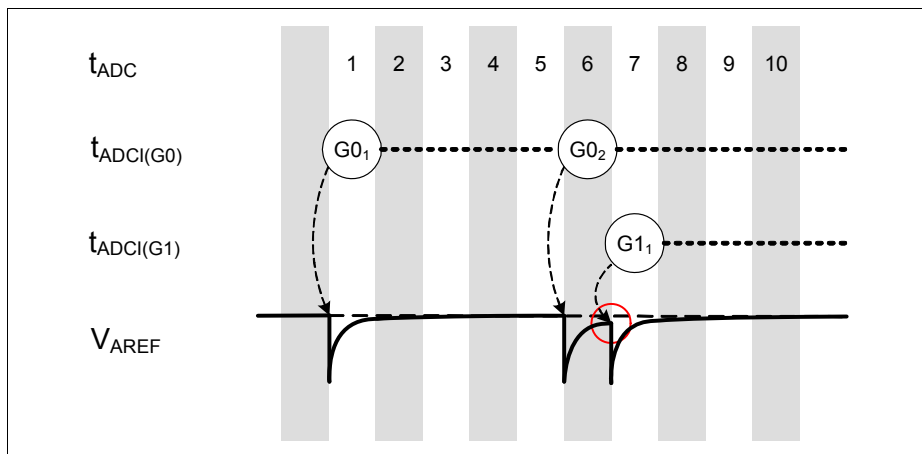
Figure 1 Influence of concurrent conversions on reference voltage

Due to this architecture, the individual prescalers may be displaced by one module clock as shown in the figure below for G0₂ and G1₁. In this example the division factor is 5 (DIVA=4).

In cycle 1 only the G0 conversion step is started. At start time the reference voltage is strobed and a certain amount of electric charge (see data sheet parameter Q_{CONV}) is consumed. This causes a drop of the reference voltage level V_{AREF} . Quantity of voltage drop depends on analog voltage level to convert.

In repeated measurements using the example setup errors up to 25 LSB have been observed in 10-16 of 4096 conversions. Magnitude of the error however depends on the system configuration and load. The workaround therefore should be applied for all applications.

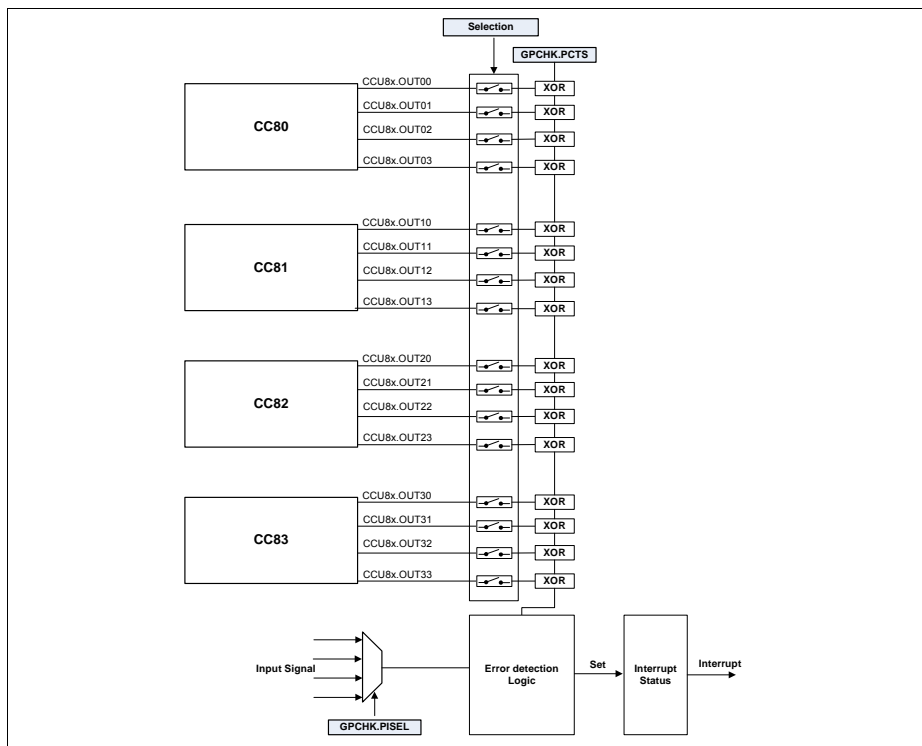
Figure 2 Parity Checker diagram

This means that if in the previous PWM cycle an error was detected and one interrupt was triggered, the software needs to read back the status register before the end of the immediately next PWM cycle.

This is indeed only necessary if multiple interrupt sources are ORed together in the same interrupt line. If this is not the case and the parity checker error source is the only one associated with an interrupt line, then there is no need to read back the status information. This is due to the fact, that only one action can be triggered in the software routine, the one linked with the parity checker error.

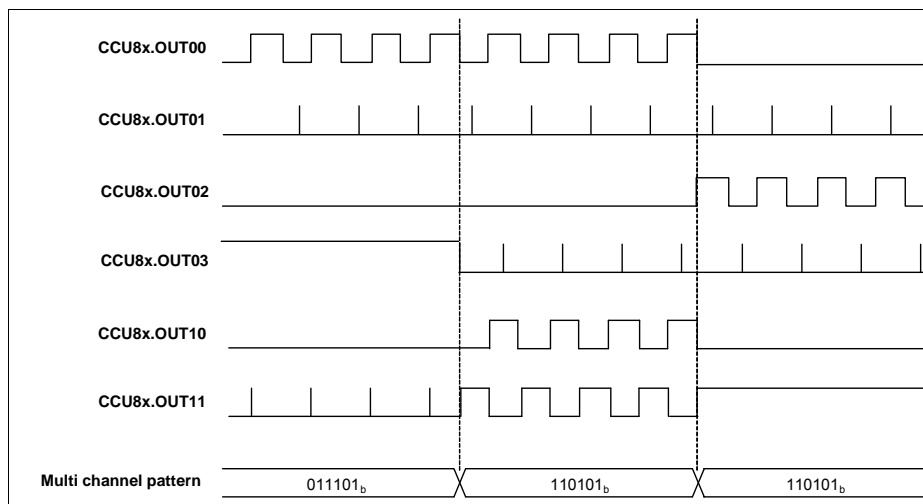
Figure 5 PWM output glitch

A glitch is present at the PWM outputs whenever the dead time of the specific compare channel is enabled - CC8yDTC.DTE1 and/or CC8yDTC.DTE2 set to 1_B (each compare channel has a separate dead time function) - and the specific multi channel pattern for the channel is 01_B or 10_B.

This glitch only affects the PWM output that is linked to the inverting ST path of each compare channel (non inverting outputs are not affected).

The effect of this glitch can be seen in Figure 3. The duration of the PWM glitch has the same length has the dead time value programmed into the CC8yDC1R.DT1F field (for compare channel 1) or into the CC8yDC1R.DT2F.

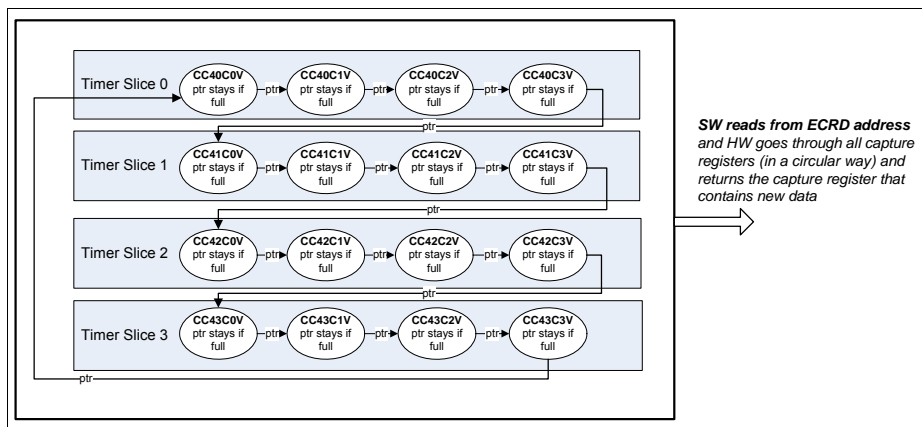
Figure 7 Extended Read Back access - example for CCU4 (CCU8 structure is the same)

- Timer X has 4 capture registers and is the only Timer set with ECM = 1_B . At the moment that the software starts reading the capture registers via the ECRD address, we have already captured two values. The ECRD read back will output CC4xC2V -> CC4xC2V (CC4xC3V value is lost)

- Timer X and Timer Y have 4 capture registers each and they are both configured with ECM = 1_B . At the moment that the software starts reading the capture registers via the ECRD address, we have already captured two values on Timer X and 4 on Timer Y. The ECRD read back will output CC4xC0V -> CC4xC1V -> CC4xC2V -> CC4xC3V -> CC4yC2V -> CC4yC2V (CC4yC3V value is lost)

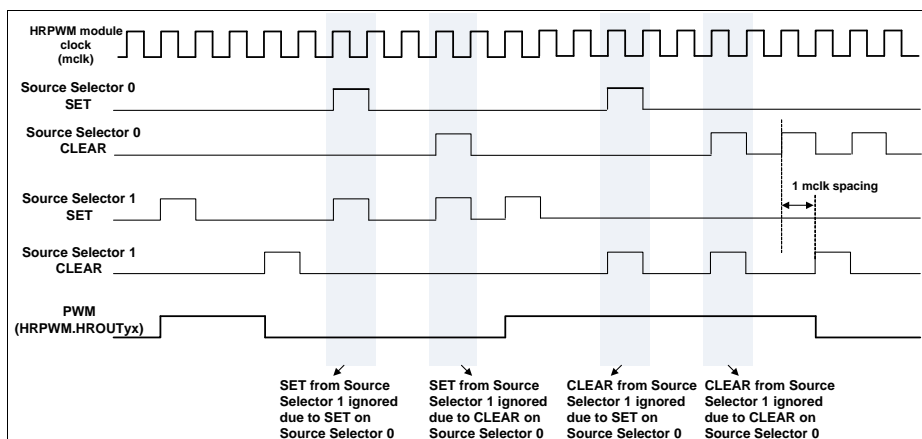
Figure 11 Collision between signals of the two Source Selectors - valid

- at the same module clock time frame Source Selector 0 and Source Selector 1 both decode a signal (a PWM set or PWM clear).

If the described condition occurs, then the signal generated by Source Selector 1 is lost and the PWM signal is not handled properly - **Figure 11**.

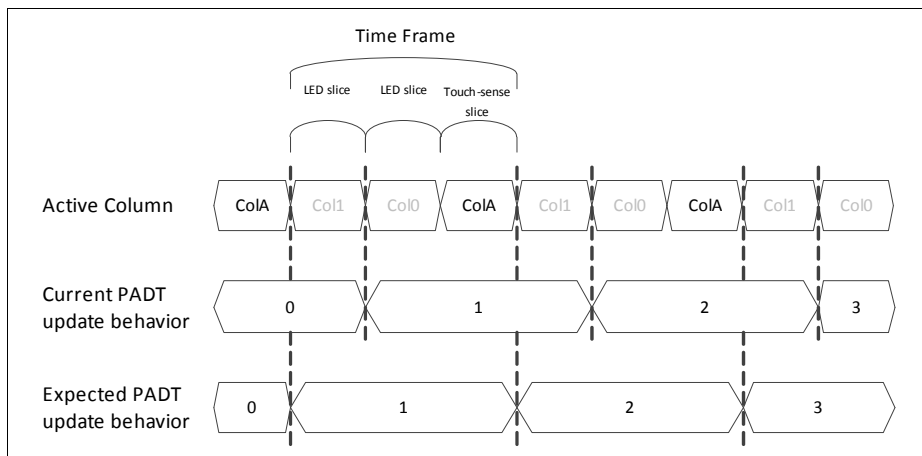
Figure 13 PADT update behavior

The touch-sense pad turn (PADT) value is updated, not at the end of the touch-sense time slice (CoIA), but one time slice later (**Figure 13**).

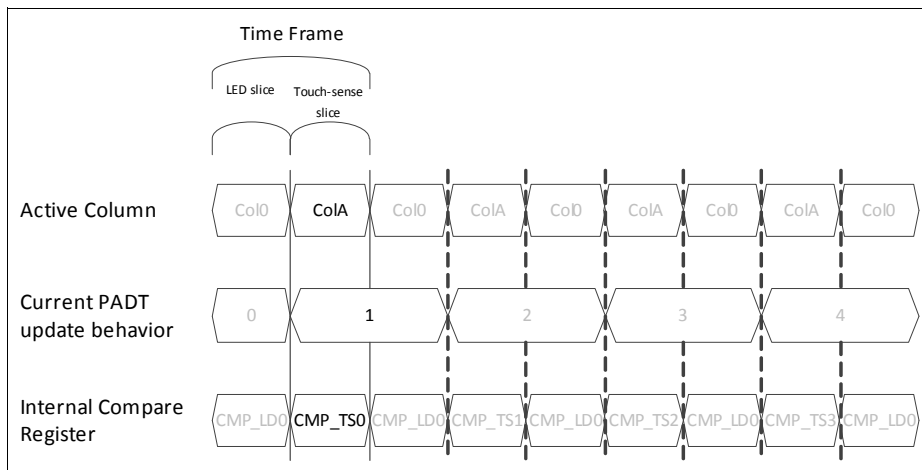
Figure 14 Effect of delay on the update of Internal Compare Register with 1 LED column enabled

If the number of LED columns enabled is smaller than 2, the delay will affect the activation period of the current active pad. At the beginning of every new Col A, the value of the current PADT's compare register is updated to the internal compare register. However, the delay causes the value of the previous PADT's compare register is updated to the internal compare register instead. This means that the current active pad would be activated with the duration of the previous pad's oscillation window ([Figure 14](#)). In addition to this, when no LEDs are enabled, pad turn 0 will prevail for one time slice longer before it gets updated ([Figure 15](#)).

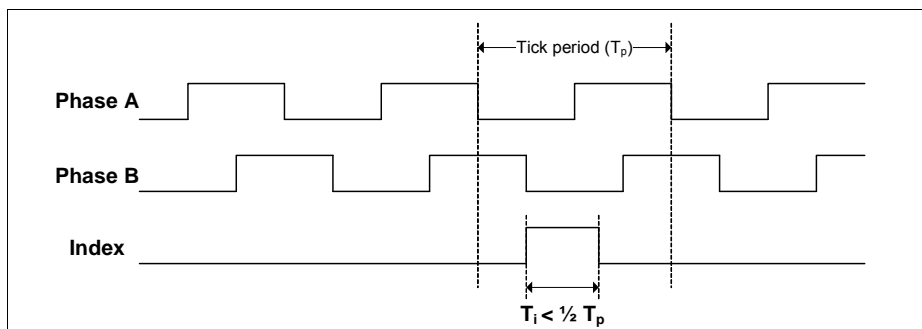
Figure 19 Different index signal types

When the index signal is smaller than 1/2 of the tick period, the POSIF module is not able to decode this signal properly, Figure 2 - notice that the reference edge of the index generation in this figure is the falling of Phase B, nevertheless this is an example and depending on the encoder type, this edge may be one of the other three.

Due to this fact it is not possible to use the POSIF to decode these type of signals (index with duration below 1/2 of the tick period).

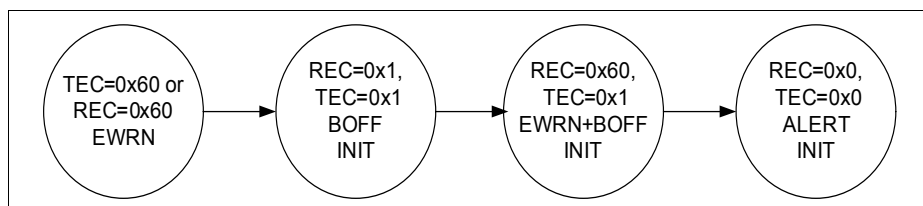
Figure 21 Alert Interrupt Behavior in case of Bus-Off

When the threshold for error warning (EWRN) is reached (default value of Error Warning Level EWRN = 0x60), then the EWRN interrupt is issued. The bus-off (BOFF) status is reached if $TEC > 255$ according to CAN specification, changing the MultiCAN module with REC and TEC to the same value 0x1, setting the INIT bit to 1_B , and issuing the BOFF interrupt. The bus-off recovery phase starts automatically. Every time an idle time is seen, REC is incremented. If REC = 0x60, a combined status EWRN+BOFF is reached. The corresponding interrupt can also be seen as a pre-warning interrupt, that the bus-off recovery phase will be finished soon. When the bus-off recovery phase has finished (128 times idle time have been seen on the bus), EWRN and BOFF are cleared, the ALERT interrupt bit is set and the INIT bit is still set.

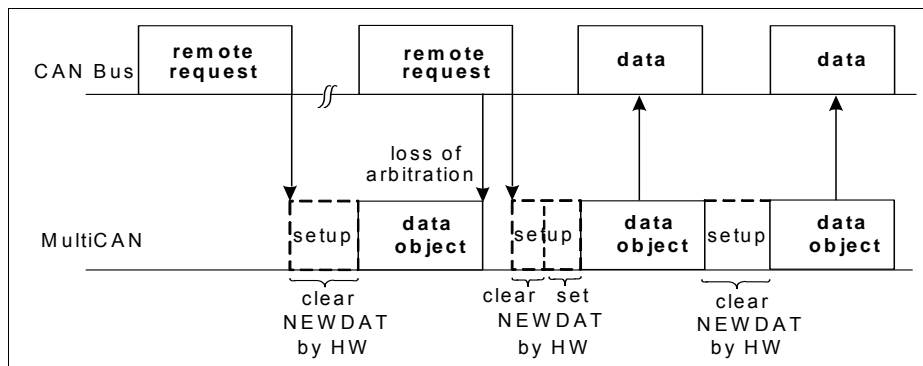
Figure 22 Loss of Arbitration

When the appropriate message object (data frame) triggered by the first remote frame wins the arbitration, it will be sent out and `NEWDAT` is not reset. This leads to an additional data frame, that will be sent by this message object (clearing `NEWDAT`).

There will, however, not be more data frames than there are corresponding remote requests.

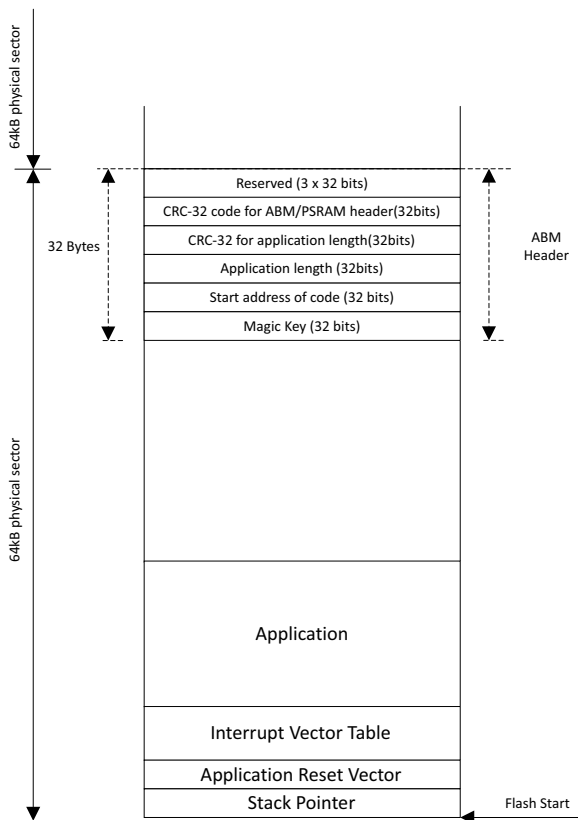
Figure 23 ABM/PSRAM Header - Location of reserved bytes

The reference manual is specifying PSRAM/ABM Header of 32 byte size. Only for 20byte of these 32 bytes the functionality is defined. The remaining 12bytes are reserved. Inside the chapter for Startup modes of the reference manual only the functional bytes are specified but not the location of the reserved bytes.

The following figure provides a detailed view on the location of the reserved bytes:
