AURIX™ TC39x errata sheet

Marking/Step: (E)ES-BD, BD

10520AERRA

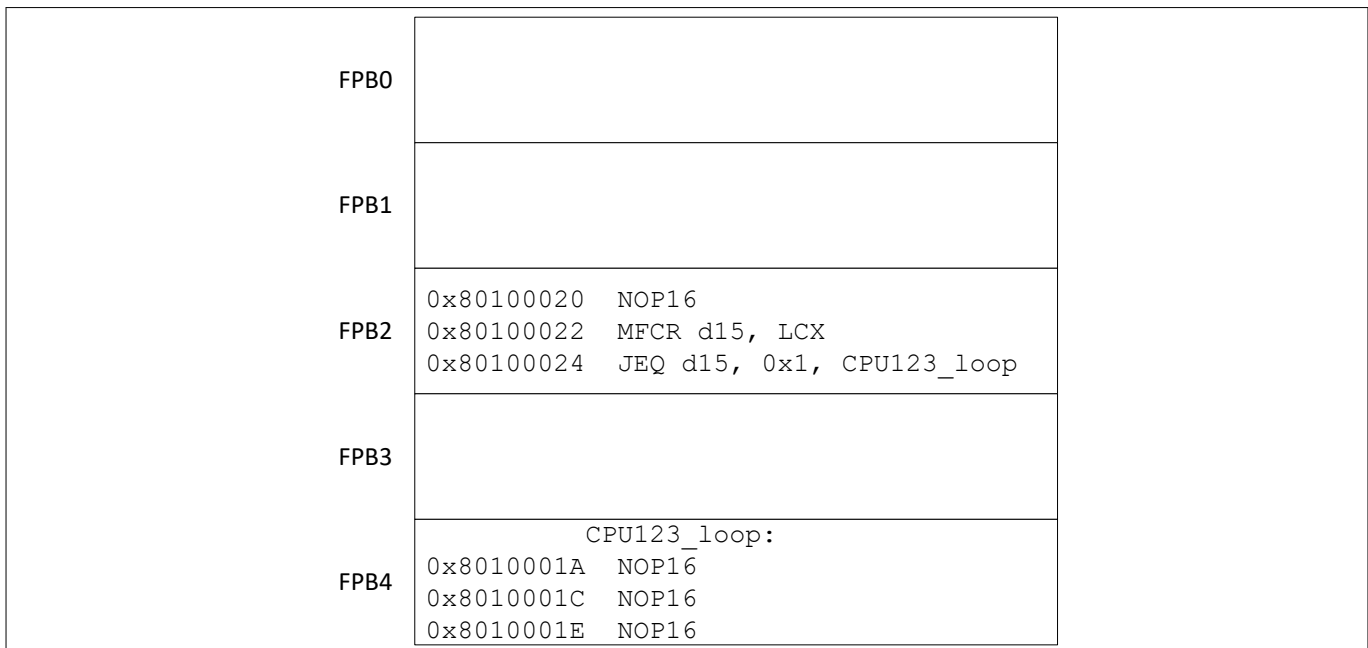
Figure 1 Example of CPUx flash prefetch buffer allocation

The code fits completely inside two flash prefetch buffers (due to the alignment).

While the loop condition remains true (d15==1), the 3 remote CPUs will continue fetching and sustaining the critical access rate causing a CPUx to potentially live-lock if all remote CPUs are running concurrently.

The erratum is limited to the specific scenario where other masters access the same NVM bank as that of CPUx. In this case, the CPUx can be locked out of its own NVM interface, causing it to stall indefinitely. It's important to note that this issue only occurs under above listed specific conditions.

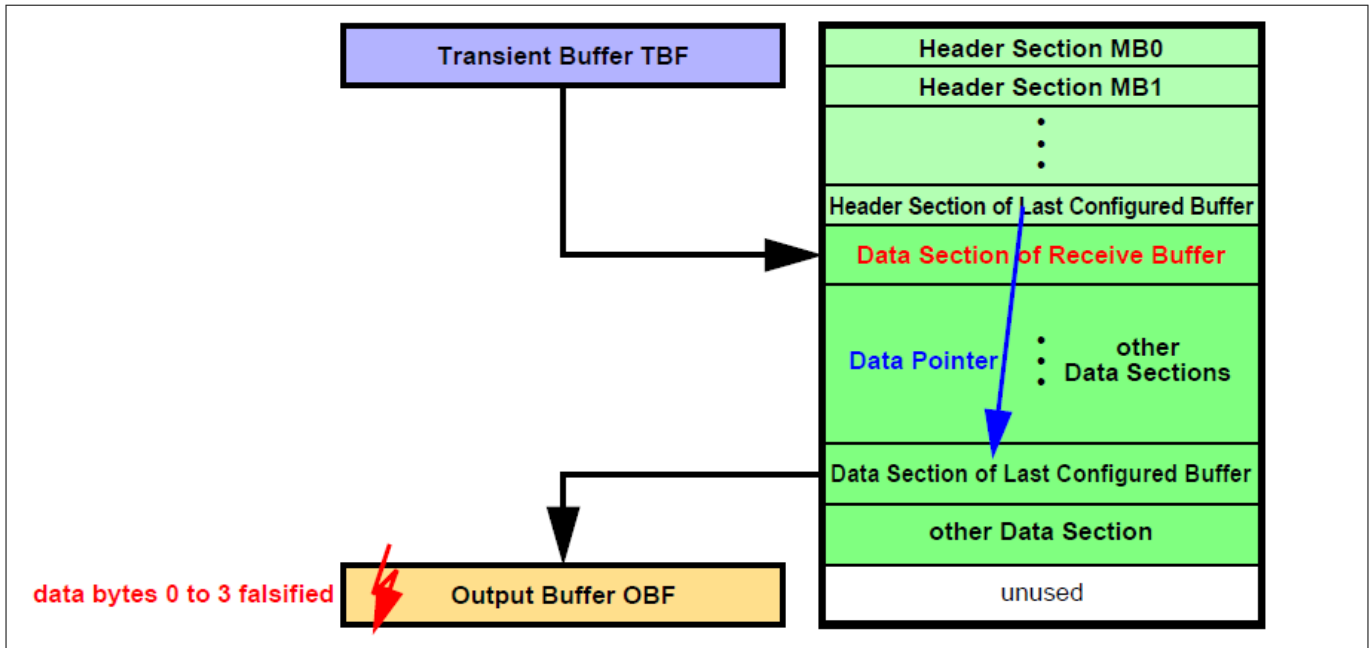
Figure 2 Message buffer transfer from Message RAM to OBF

When the message buffer has its payload configured to maximum length (`PLC = 127`), the OBF word on address `00h` (payload data bytes 0 to 3) is overwritten with unexpected data at the end of the transfer.

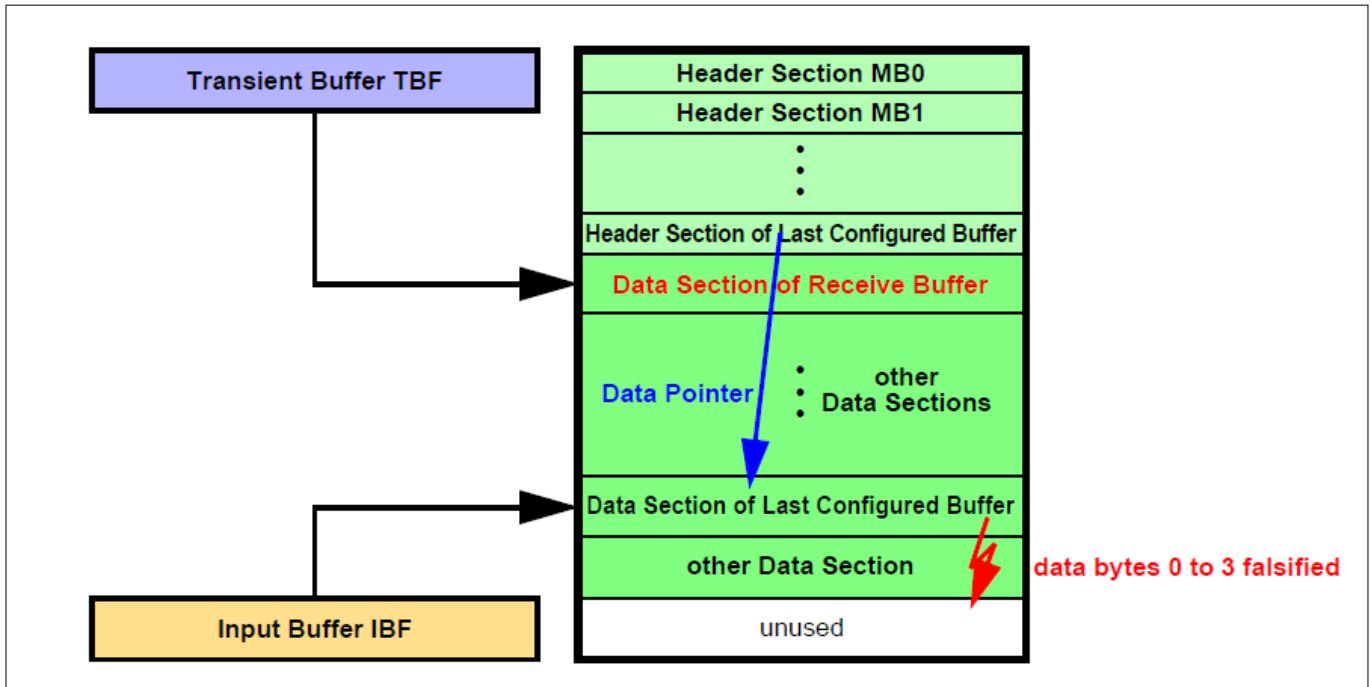
Figure 3 Message buffer transfer from IBF to Message RAM

After the Data Section of the selected message buffer in the Message RAM has been written, one additional write access overwrites the following word in the Message RAM which might be the first word of the next Data Section.

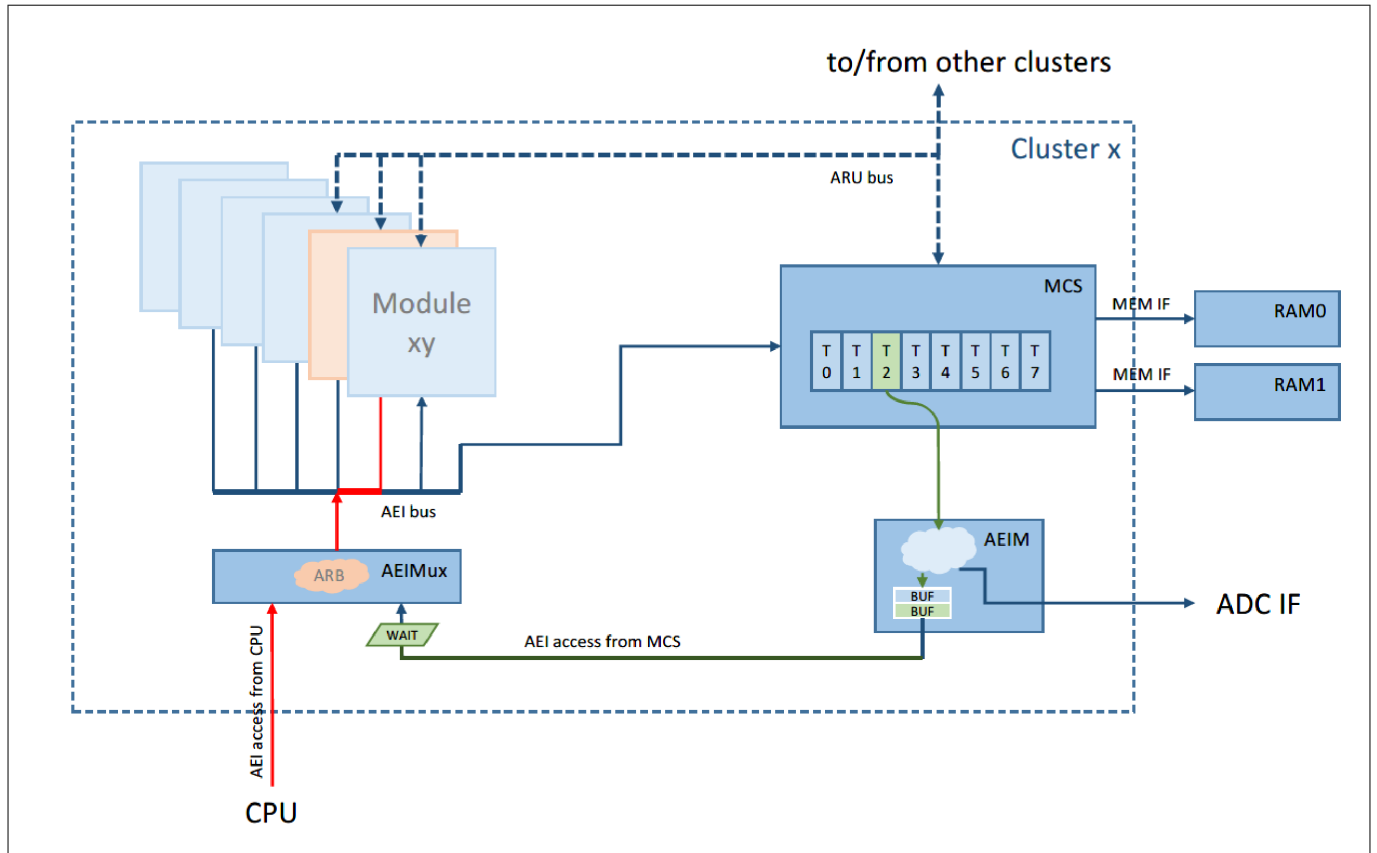
Figure 6 MCS AEI master access path

Figure 6 shows an uncritical traffic situation. Here an access of a MCS thread to the AEI bus (green access path) is temporary delayed due to an ongoing AEI bus access from the CPU (red access path). The MCS access to the AEI bus will be safely buffered at the AEIM (green buffer). As soon as the CPU access to the AEI bus completes, the buffered AEI bus access from MCS will be executed.

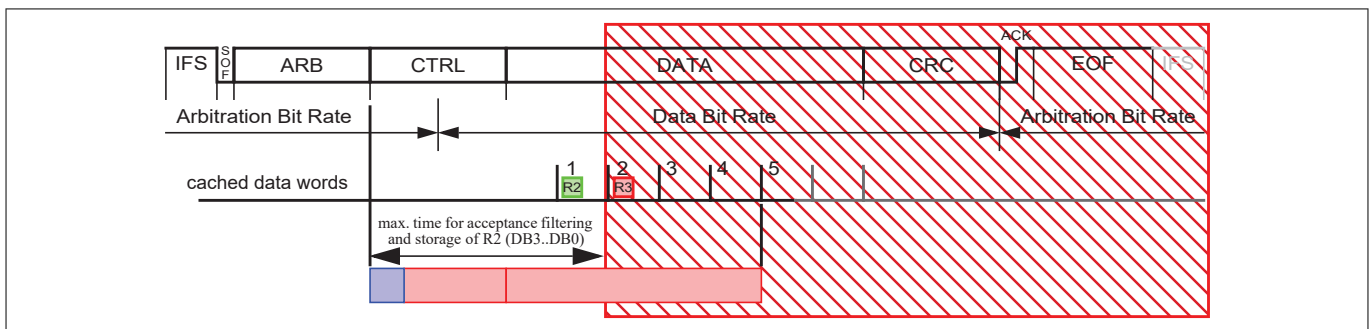
Figure 11 CAN Frame with DLC > 4

The figure that follows shows how the available time for acceptance filtering and storage is reduced.

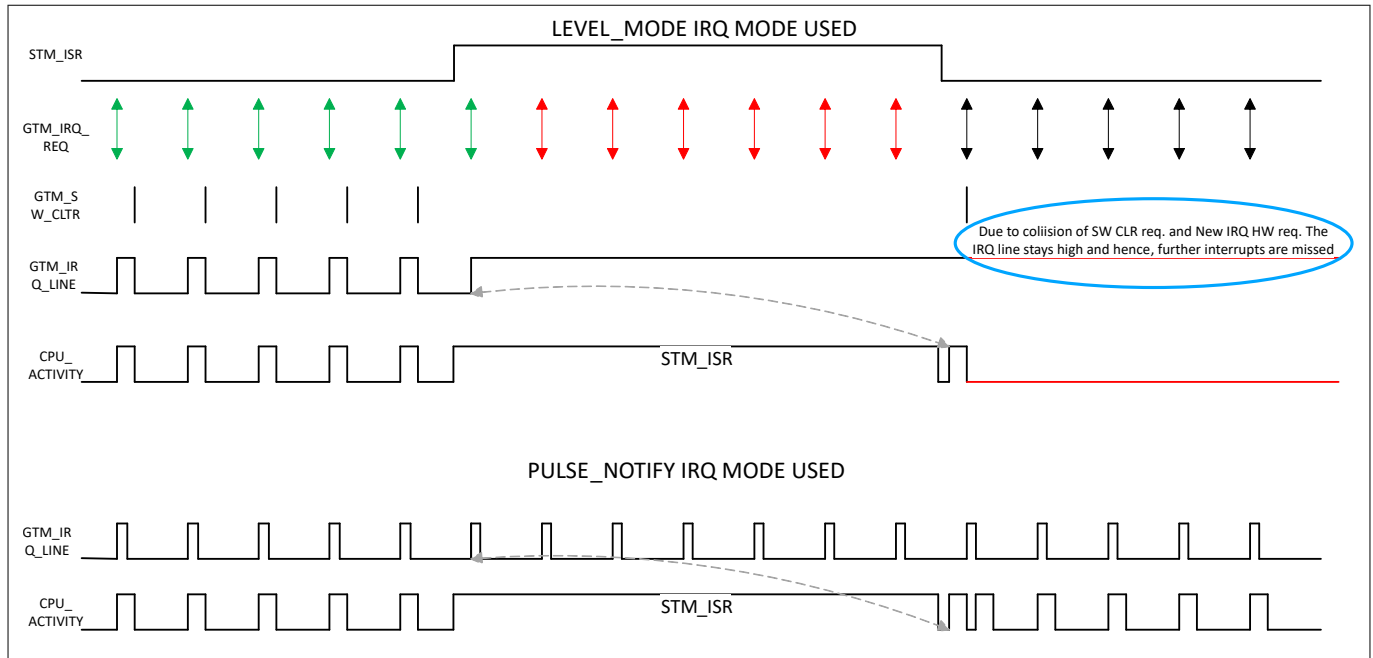
Figure 12 Interrupt Level vs. Pulse-Notify mode - Corner Case Example

interrupt and clear events), GTM_IRQ_XXX is not cleared and remains high. As a consequence, the IR observes no transition on GTM_IRQ_XX. Thus, any forthcoming interrupt events in this scenario are lost as there is no chance to release the CPU IRQ when a collision happens as shown in Figure below.

If Pulse-Notify mode is selected, every internal trigger will be forwarded to the IR, irrespective of the time of occurrence and the clear event, as the pulse-notify leads to set and reset of GTM_IRQ_XXX as compared to only setting of the GTM_IRQ_XXX line in Level mode.

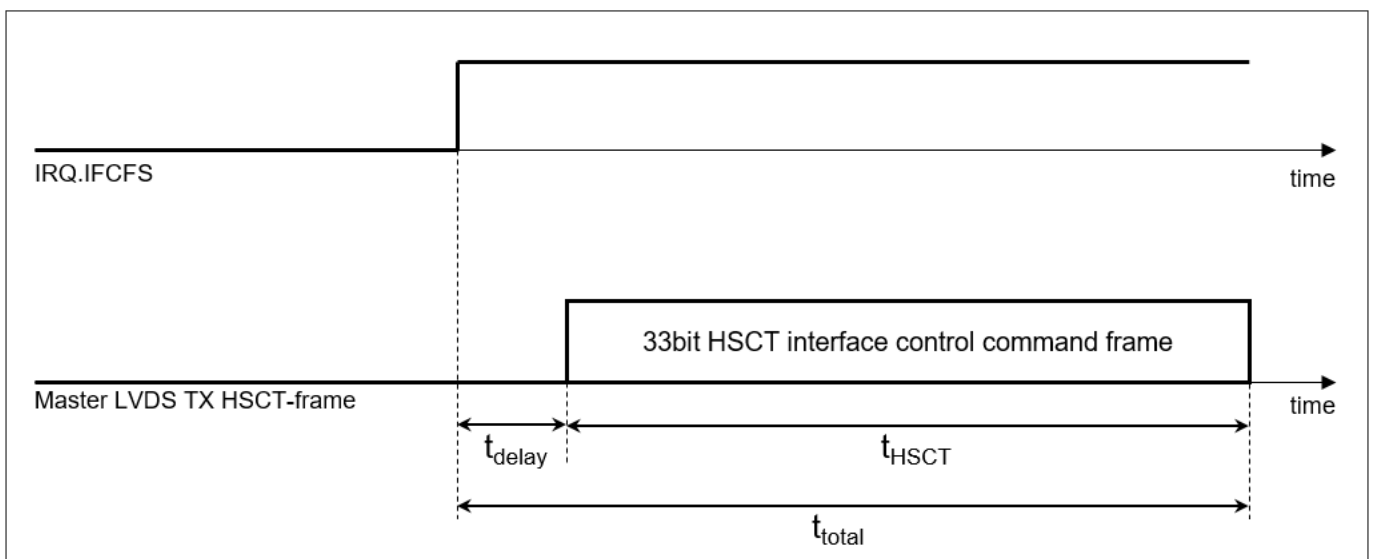
Figure 13 Timing of LVDS TX interface command sending in relation to IRQ.IFCFS

the user might falsely assume that also the actual sending on the LVDS TX port has already occurred once the IRQ.IFCFS flag is set, which is not true.

Instead the timing shown in the following figure applies.

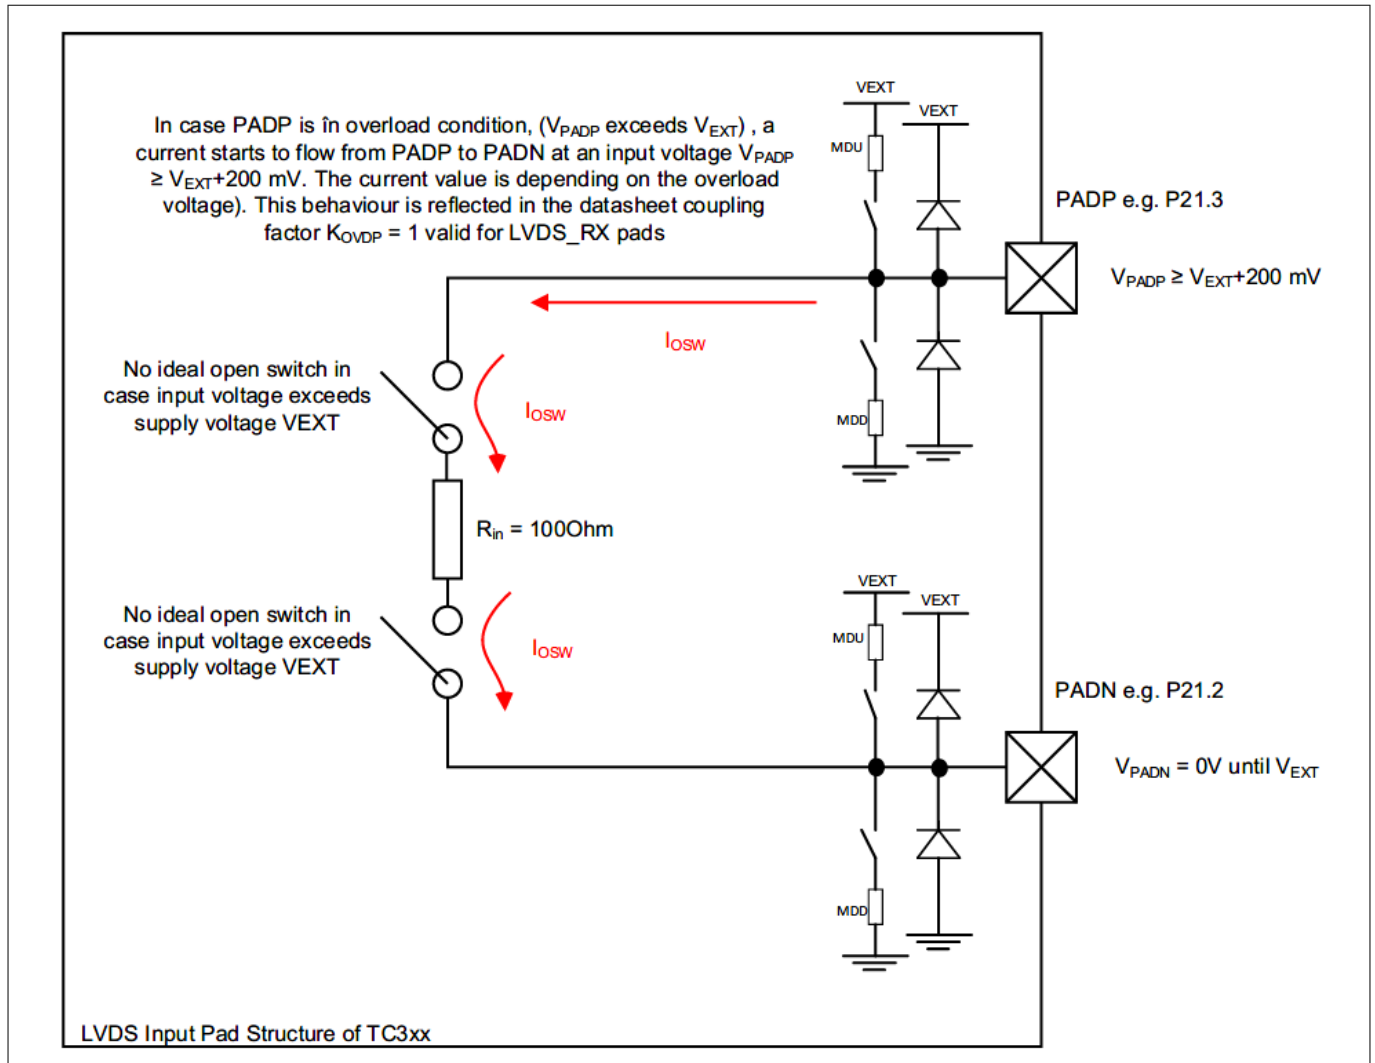
Figure 14 Positive overload on P-pad of a LVDS RX pin pair (both used as inputs)

The overload current I_{OSW} through the non-ideal open switch significantly increases when $V_{PADP} \geq V_{EXT} + 200$ mV.

Note: In general, the effect will also occur if the N-pad is used as output, or for a negative overload condition on either the P-pad or the N-pad.
