AURIX™ TC23x errata sheet

Marking/Step: ES-AC, AC

About this document

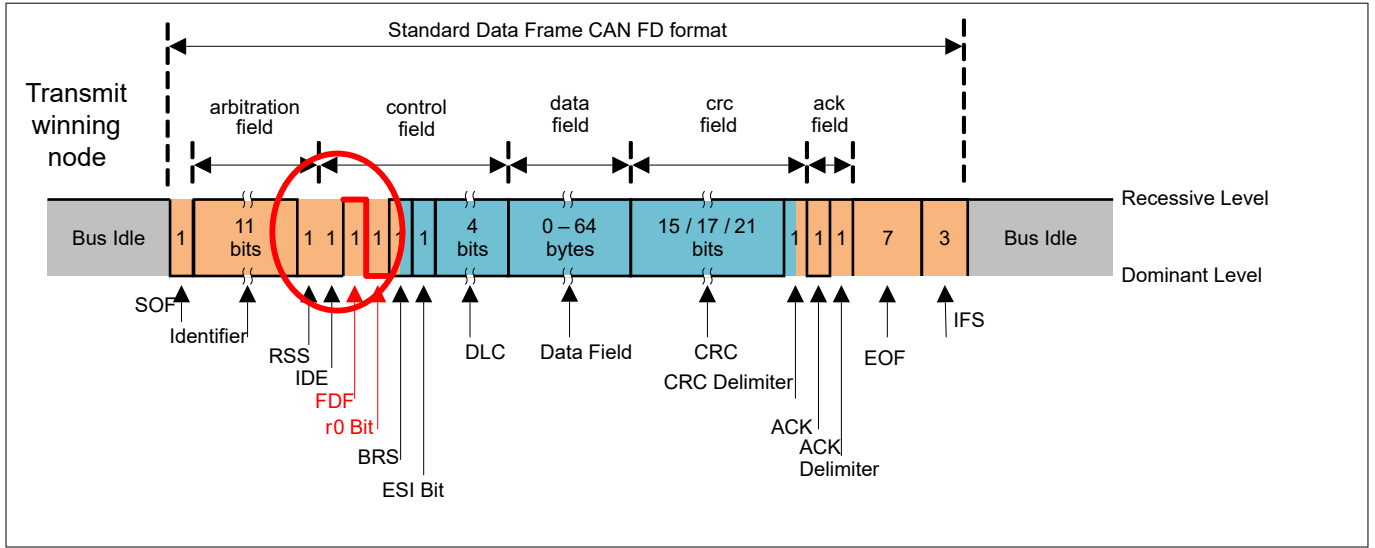
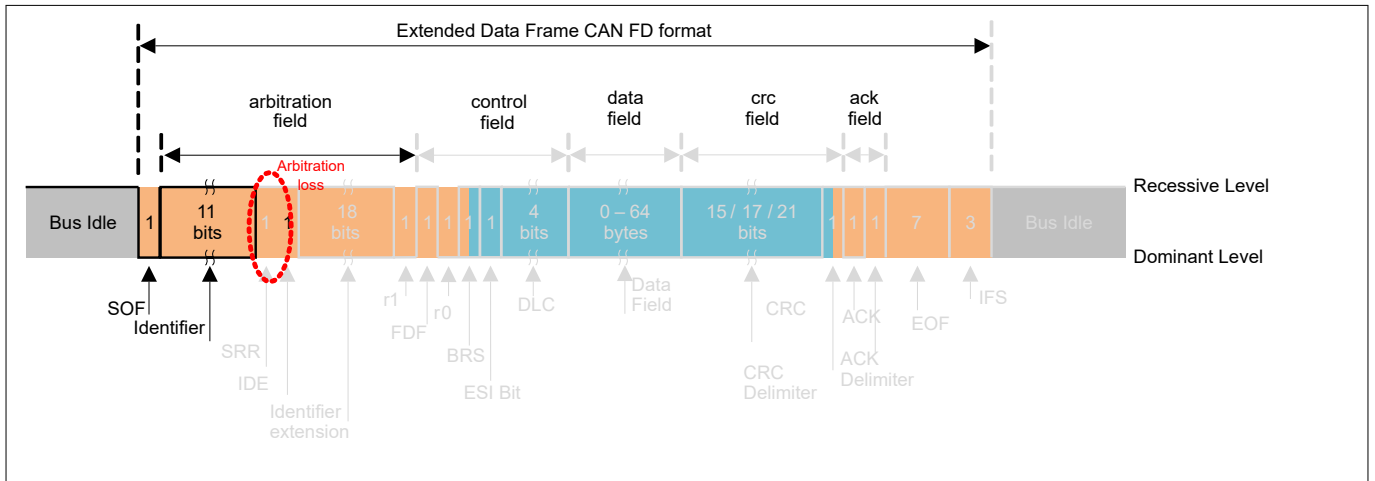
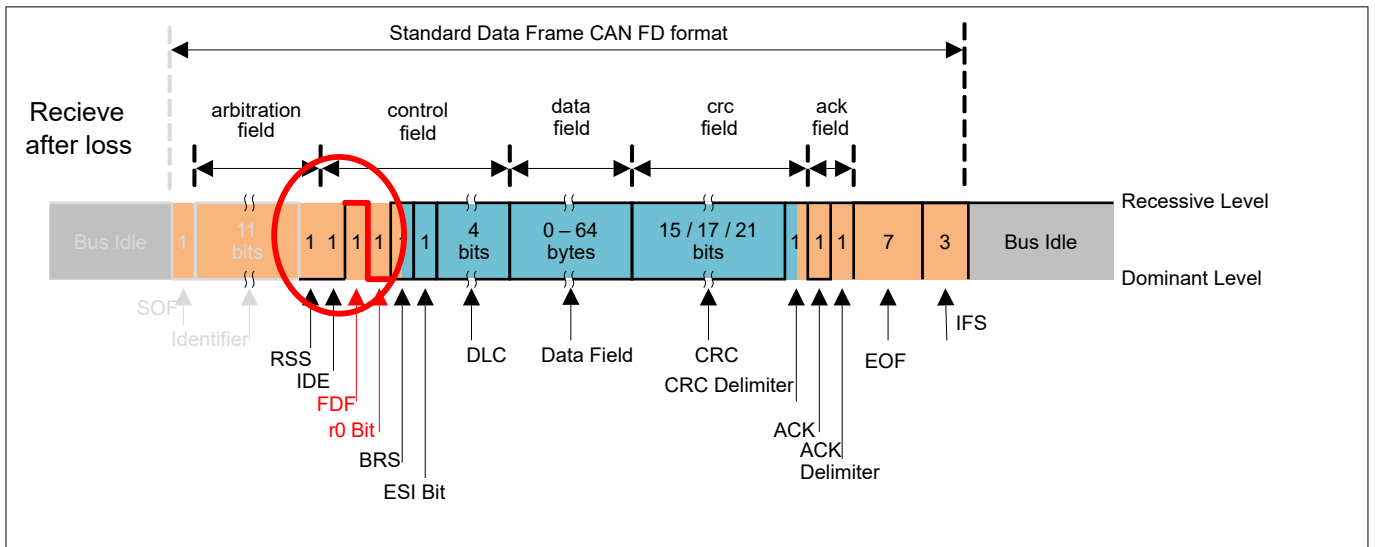
The device is producing more error frames within a network than a device with a hardsync at the FDF bit.

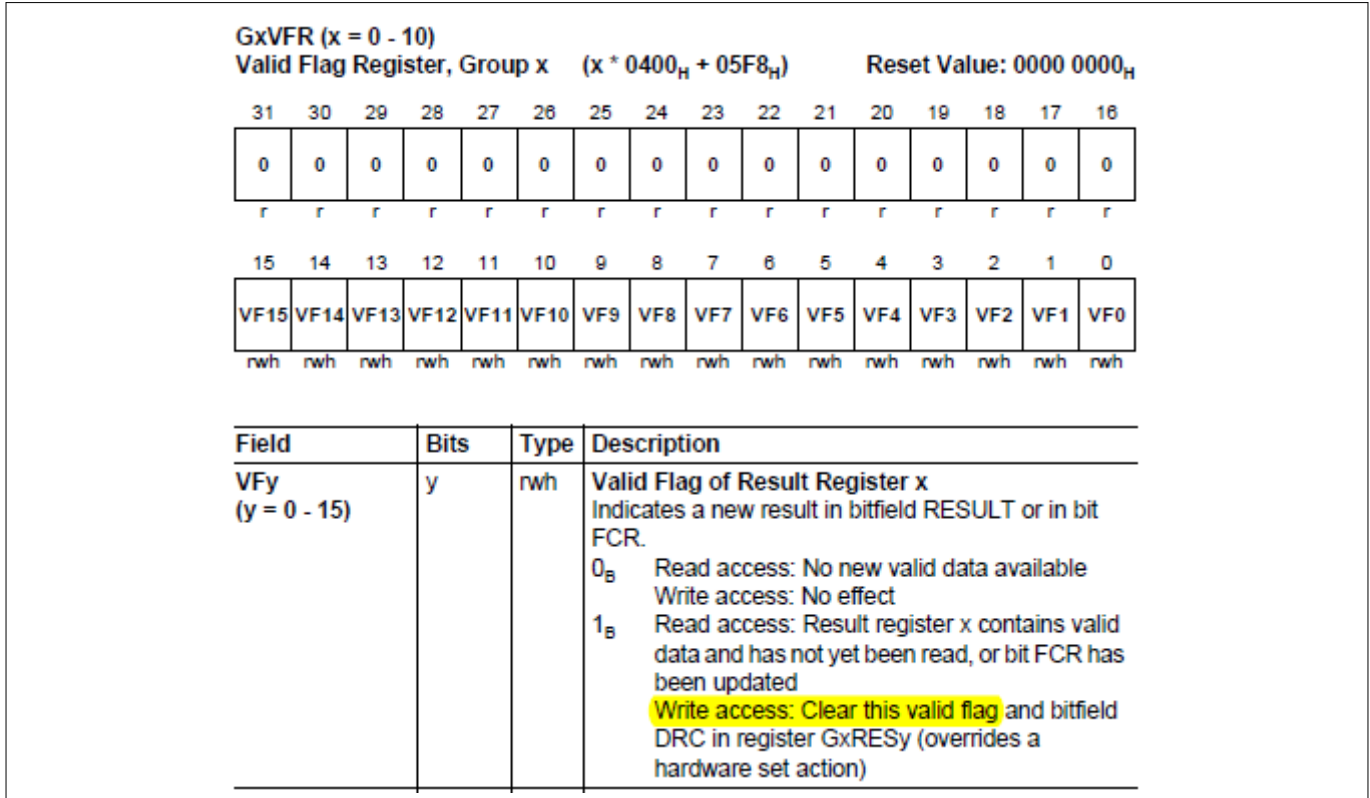
Figure 7 Register GxVFR in the VADC Module of TC2xx Devices

The bits in the GxVFR register have to be written with 1_B to clear a valid flag VFy indicating a valid result. Assuming VFy = 1_B, if one of the RMW instructions listed above is used, the write to VFy would never happen since VFy is already set to 1_B. This means that the next read of VFy may lead to incorrect conclusions by software.

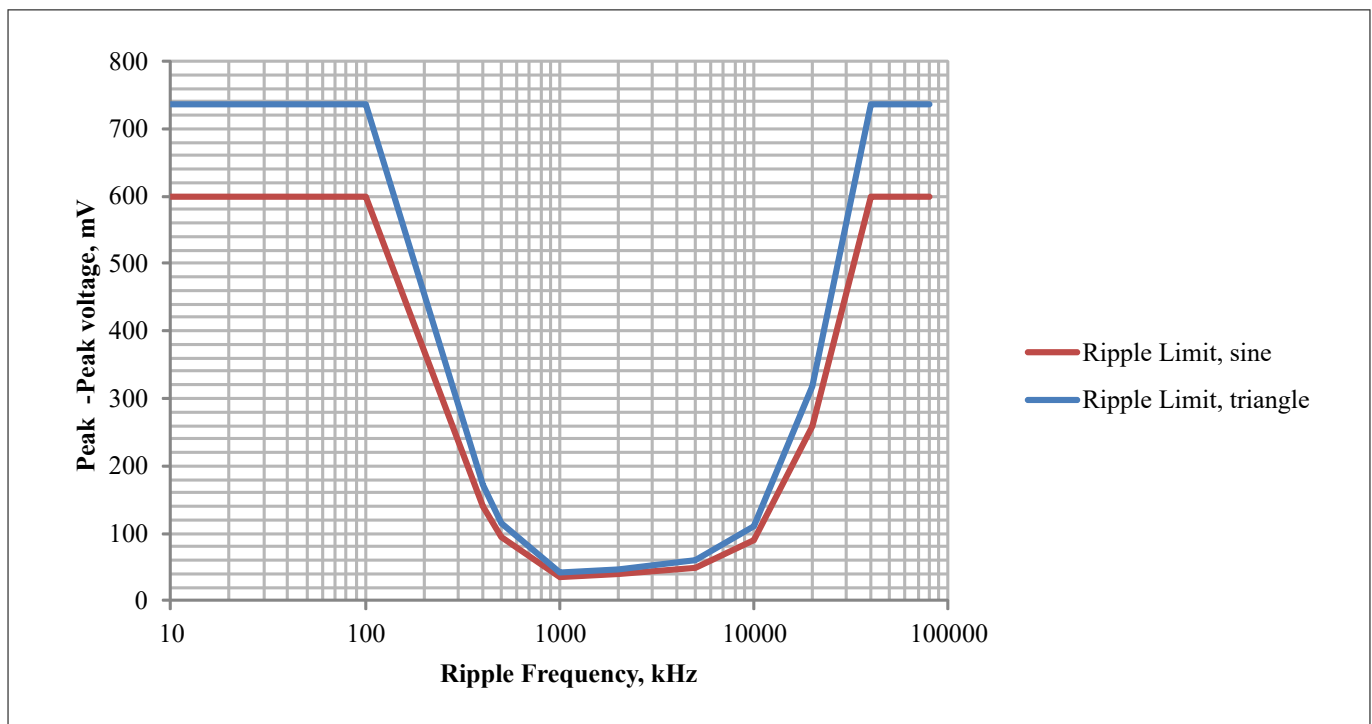
Figure 14 Ripple Voltage vs. Frequency Characteristic

The internal back-up clock is sensitive to specific power supply voltage disturbance/ripple caused by a voltage ripple intrinsic to DC-DC converters. Specific conditions such as insufficient filtering of the ripple may lead to improper behavior of the start-up scheme of the back-up clock, and thus stuck-at state during the start-up of the microcontroller until this condition is removed.

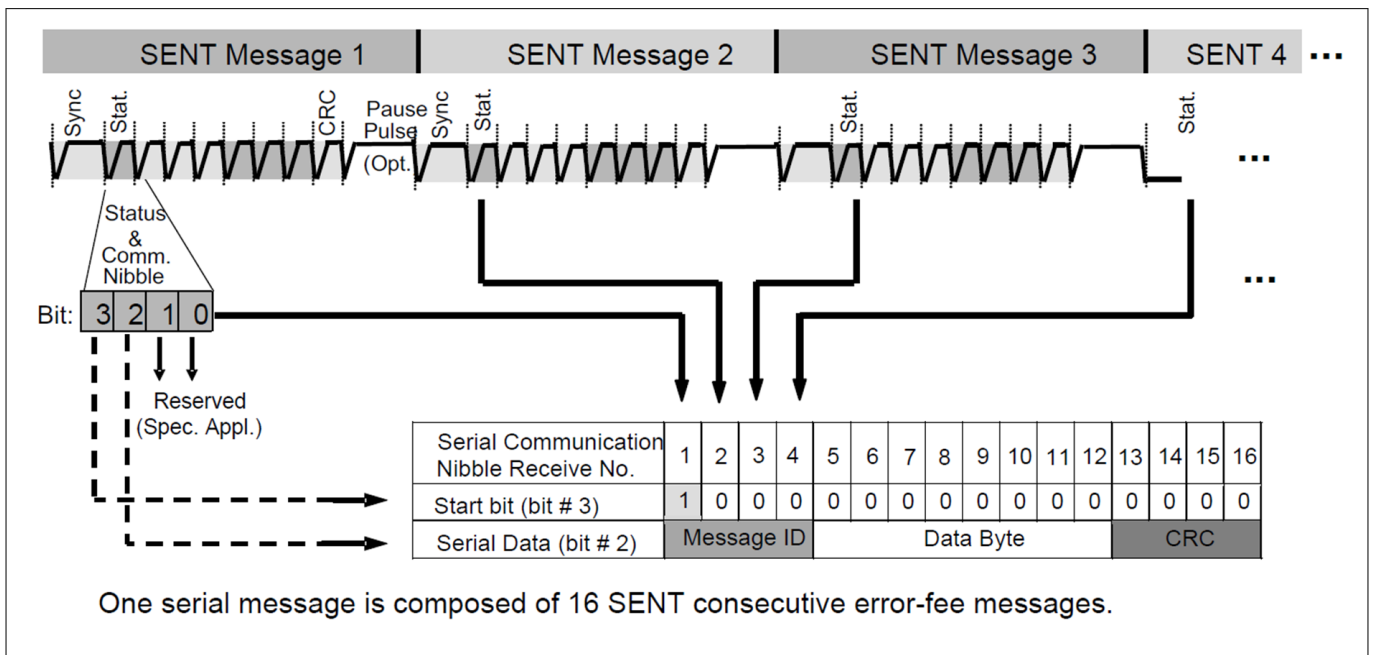
Figure 15 Short Serial Message, Serial Data Encoding over 16 messages

Figure 15 shows a corrected version of this figure.
