# AURIX™ TC26x errata sheet

**Marking/Step: ES-BC, BC**

10504AERRA

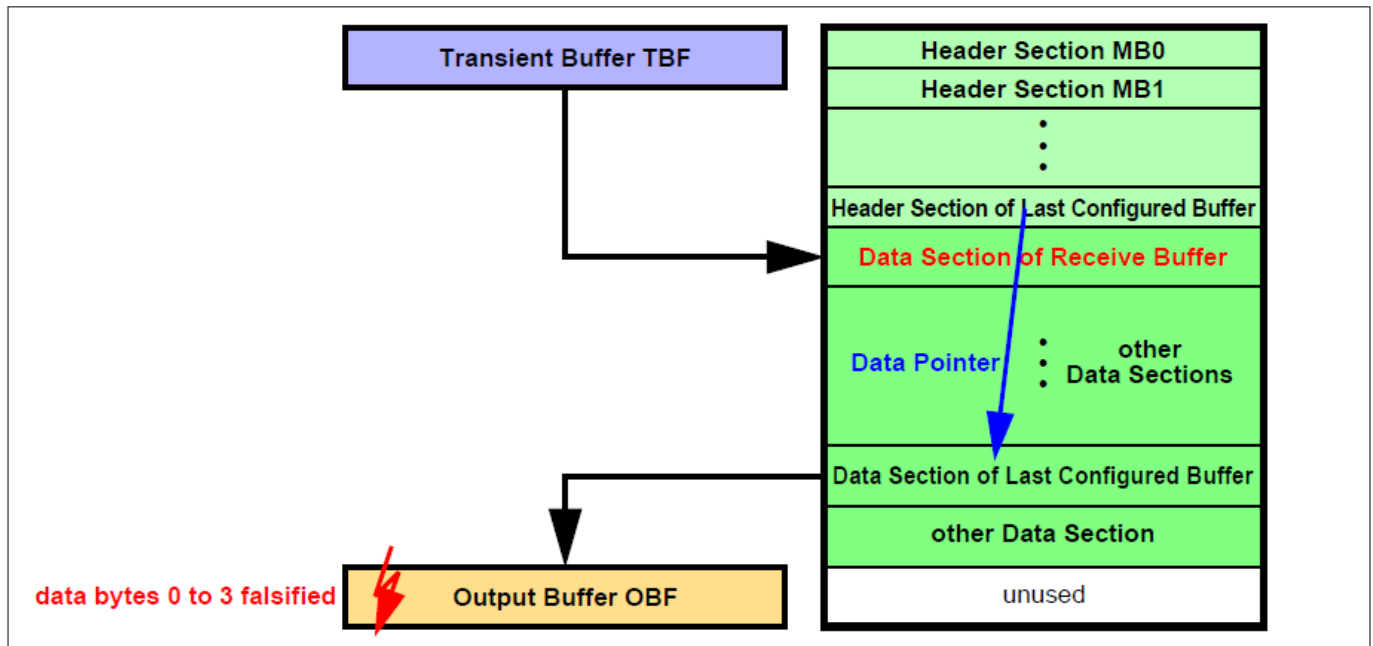
**Figure 1 Message buffer transfer from Message RAM to OBF**

When the message buffer has its payload configured to maximum length (PLC = 127), the OBF word on address 00h (payload data bytes 0 to 3) is overwritten with unexpected data at the end of the transfer.

Ensure that the Data Section directly following the Header Partition is assigned to a transmit buffer.

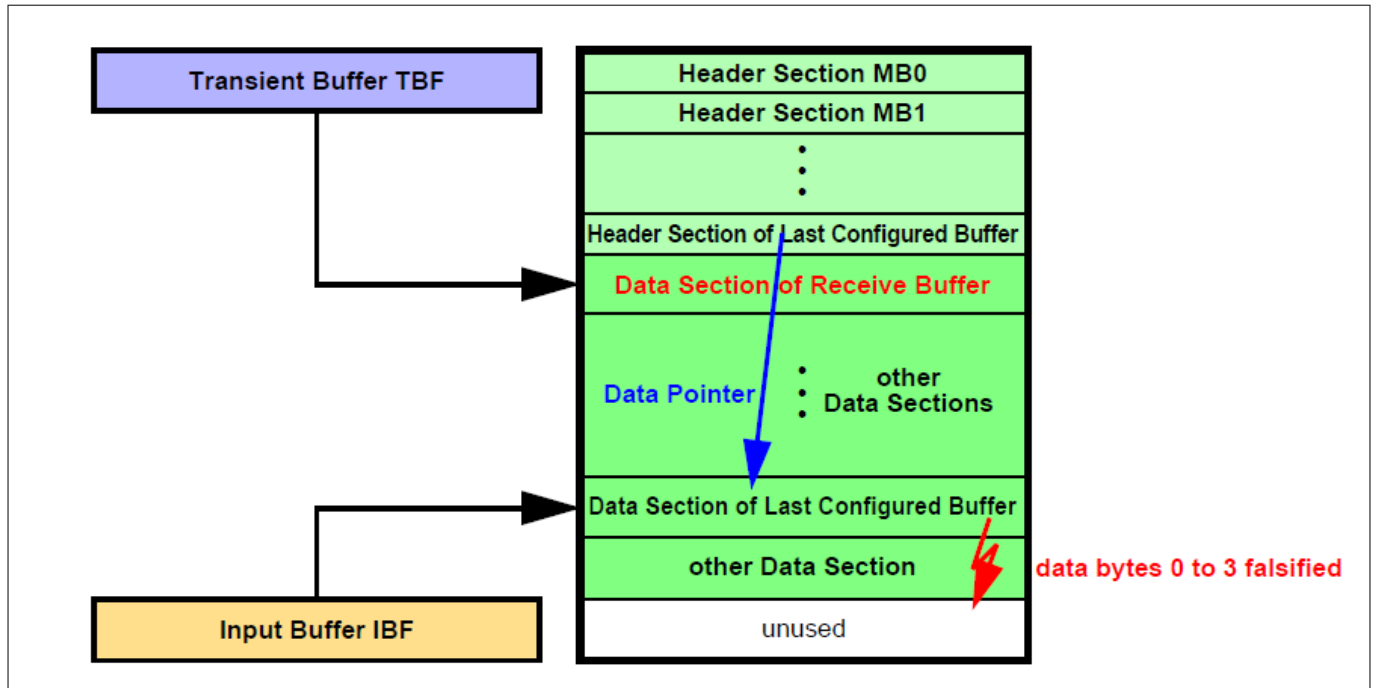
Figure 2 Message buffer transfer from IBF to Message RAM

After the Data Section of the selected message buffer in the Message RAM has been written, one additional write access overwrites the following word in the Message RAM which might be the first word of the next Data Section.

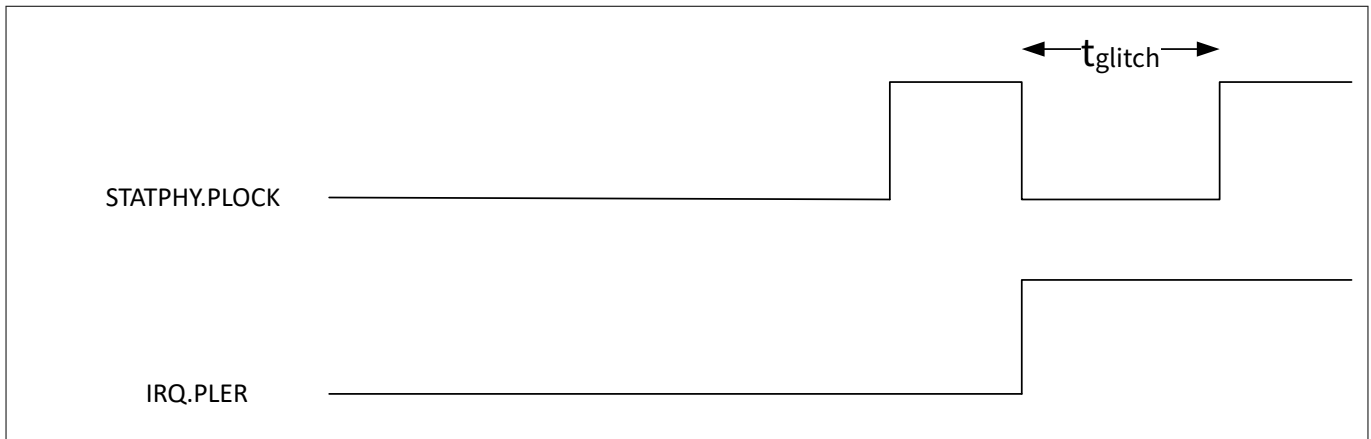
**Figure 4 PLL Unlock Event Glitch**

After STATPHY.PLOCK shows lock status, there is a possibility that the PLL is unlocked once for a short time ( $t_{glitch}$ ) again at start-up phase, as shown in the figure below. This single unlock event as indicated by STATPHY.PLOCK recovers back to lock status without any software intervention.

The minimum time duration of  $t_{glitch}$  is 224 cycles of the PLL reference clock (RefClk). An example of minimum  $t_{glitch}$  duration for RefClk with 20 MHz and 10 MHz is shown in the table below.

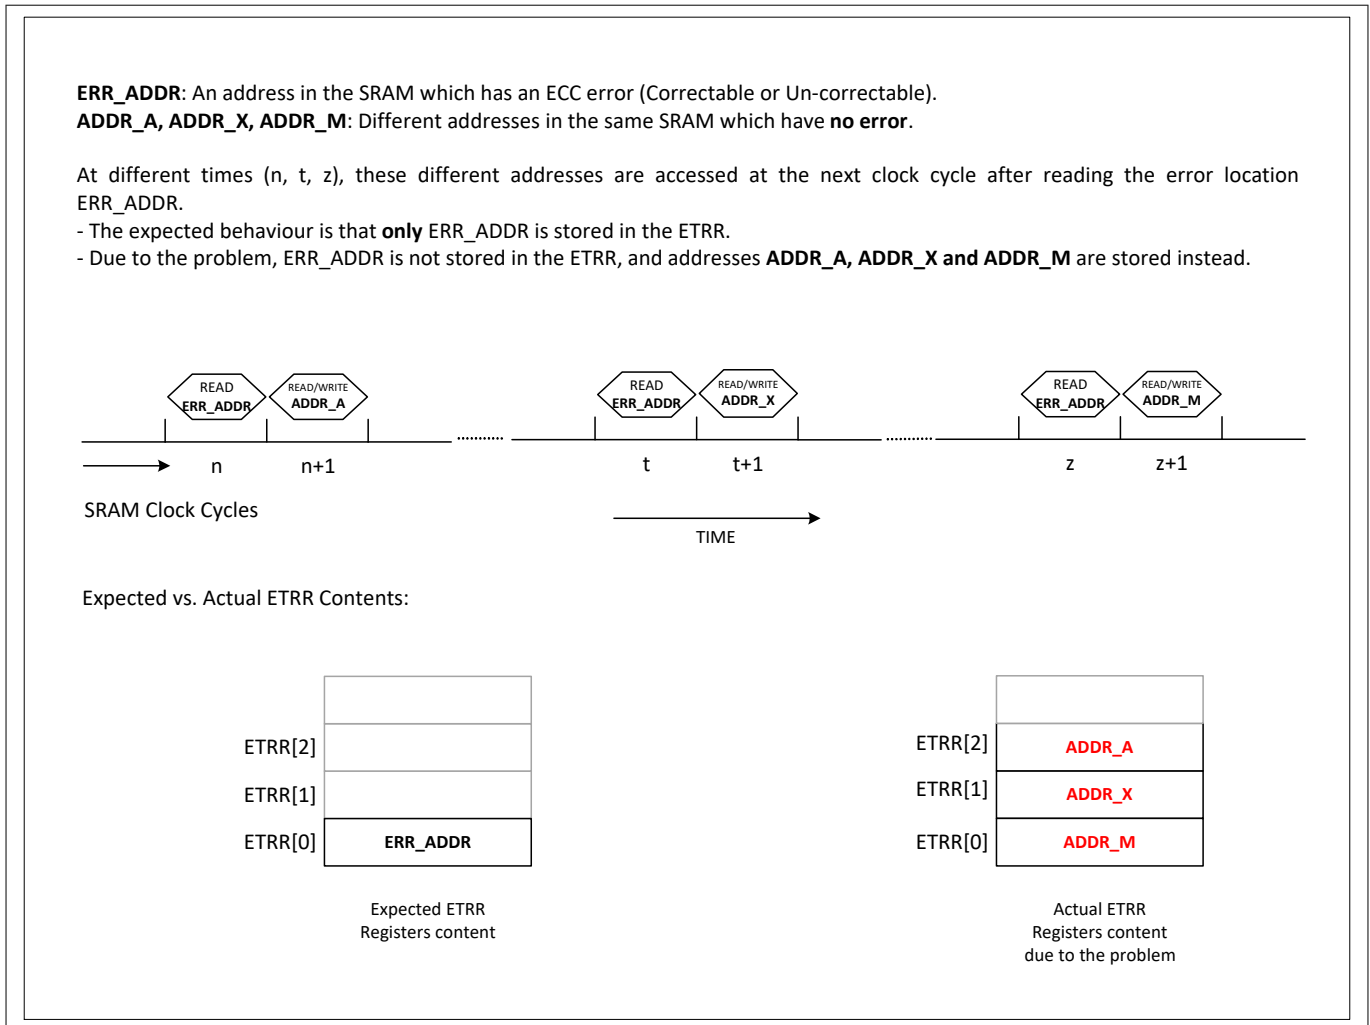
**Figure 5 Example sequence showing how registers ETRRx may be filled with “Error Free” addresses**

When such a consecutive access sequence (read from **ERR\_ADDR** followed by read/write of different address(es)) happens multiple times, registers **ETRRx** are filled with addresses that have actually no error – and the SRAM address which actually has an error is not stored indeed. [Figure 5](#) shows such an example scenario.

The consequence of the scenario explained in [Figure 5](#) is that a single error in the SRAM – example just one correctable error at a location ERR\_ADDR – can result in registers ETRRx getting filled with fault-free address, and thus potentially even triggering an ETRR overflow.

If there is at least one valid ETRR entry (i.e. MCx.ECCD.VAL ≠ 0) then the software shall run a Non-Destructive-Inversion (NDI) Test on the affected SRAM. Please refer to application note AP32197 (AURIX™ Memory tests using the MTU) for an example regarding running this test.

At the end of this test, if an ETRR overflow is detected (MCx.ECCD.EOV = 1<sub>B</sub>) then the MCU shall be considered non-operational. Refer to section on Correctable SRAM Error handling in the Safety Manual.

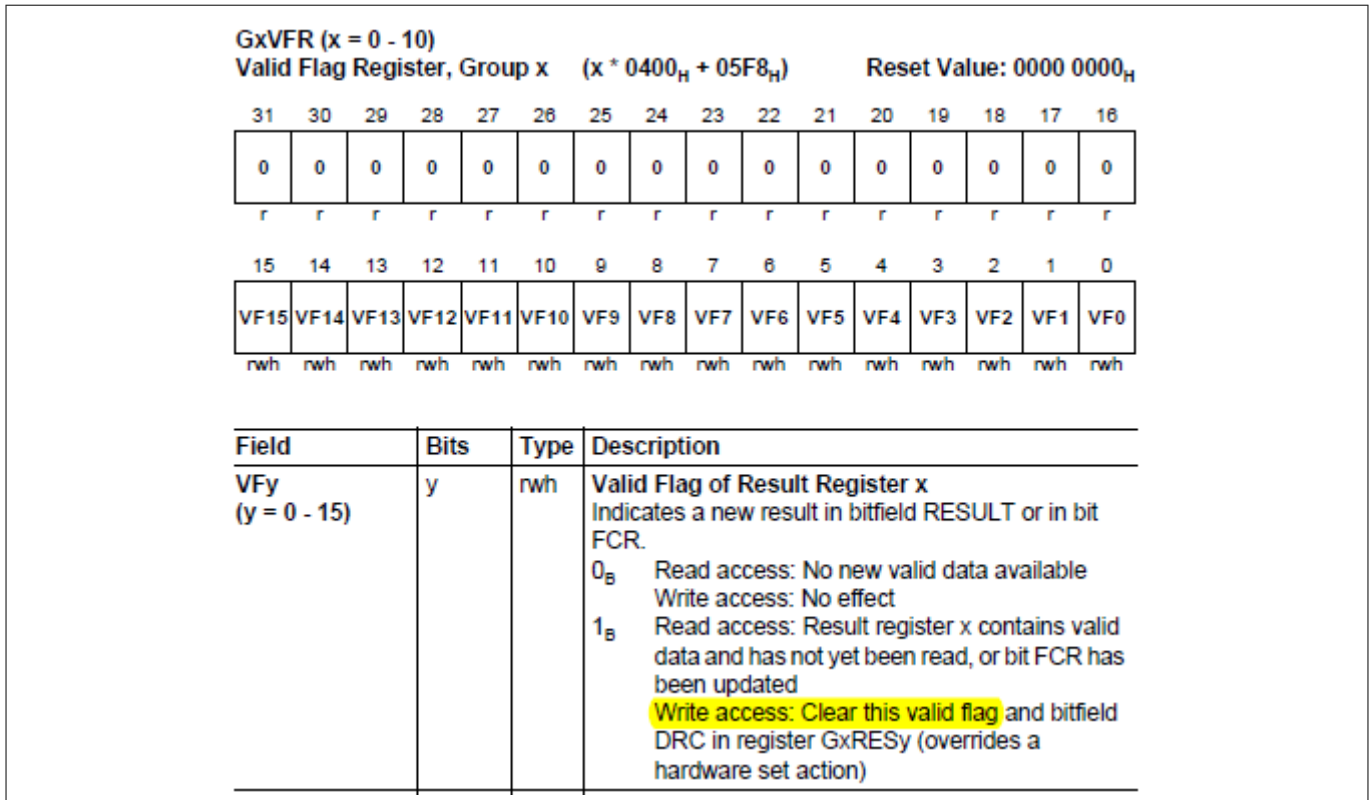
**Figure 8 Register GxVFR in the VADC Module of TC2xx Devices**

The bits in the GxVFR register have to be written with 1<sub>B</sub> to clear a valid flag VFy indicating a valid result. Assuming VFy = 1<sub>B</sub>, if one of the RMW instructions listed above is used, the write to VFy would never happen since VFy is already set to 1<sub>B</sub>. This means that the next read of VFy may lead to incorrect conclusions by software.

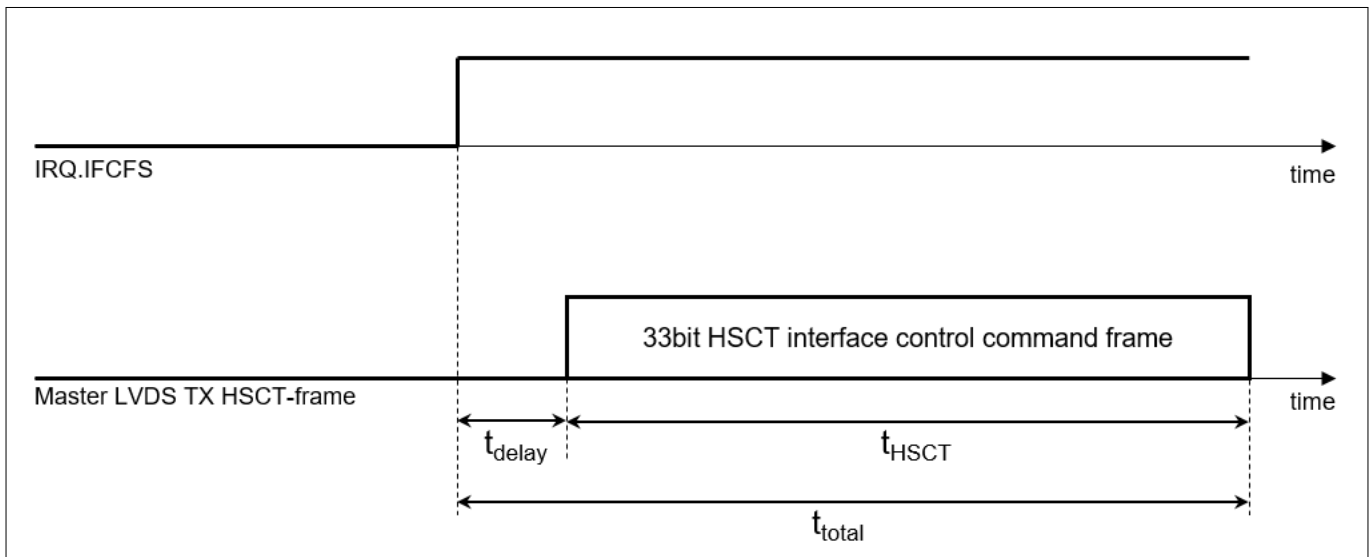
**Figure 10 Timing of LVDS TX interface command sending in relation to IRQ.IFCFS**

the user might falsely assume that also the actual sending on the LVDS TX port has already occurred once the IRQ.IFCFS flag is set, which is not true.

Instead the timing shown in the following figure applies.

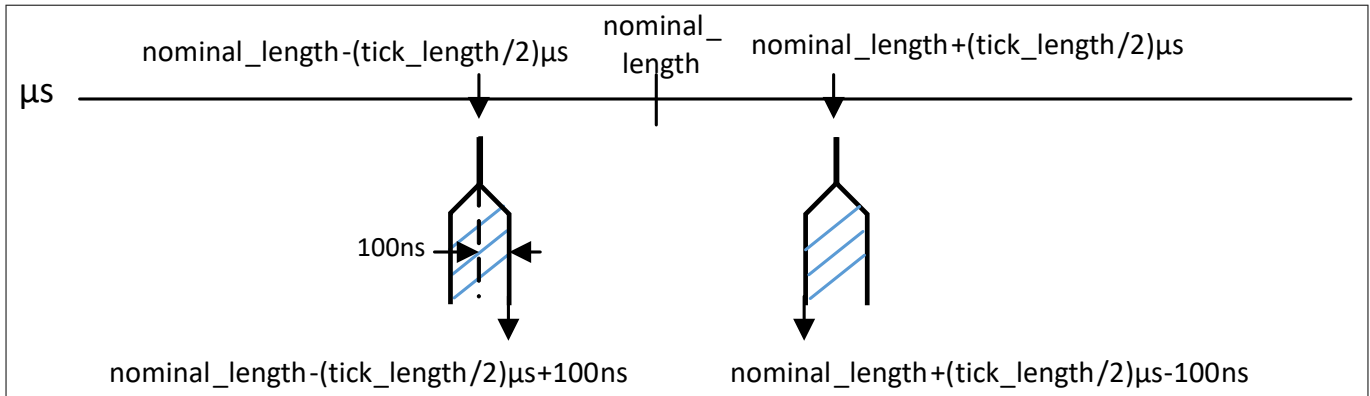
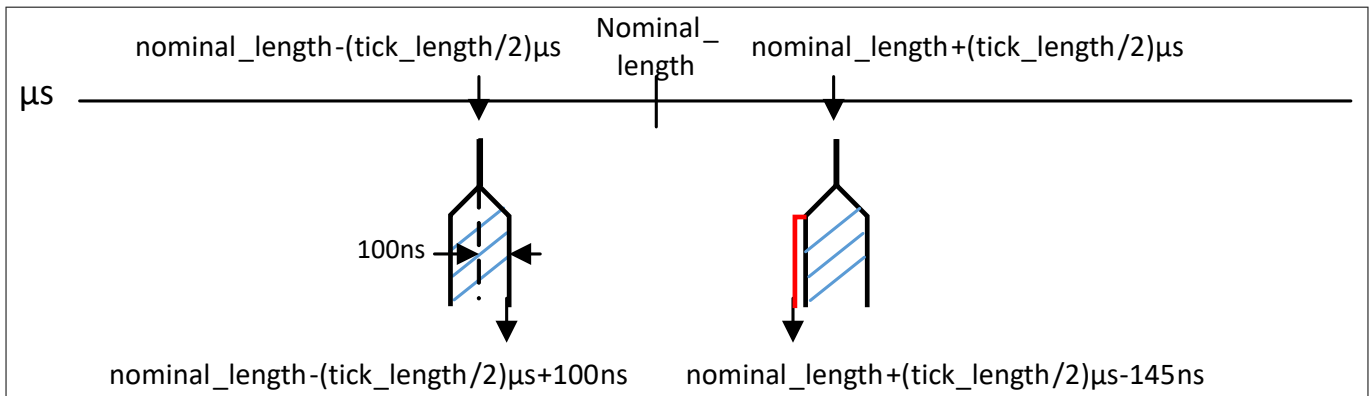
**Figure 20 SENT Tolerance of this Design Step**

- The lower border is  $\text{nominal\_value} - (\text{tick\_length}/2) \mu\text{s} + 100 \text{ ns}$
- The upper border is  $\text{nominal\_value} + (\text{tick\_length}/2) \mu\text{s} - 100 \text{ ns}$

- The lower border is  $\text{nominal\_value} - (\text{tick\_length}/2) \mu\text{s} + 100 \text{ ns}$
- The upper border is  $\text{nominal\_value} + (\text{tick\_length}/2) \mu\text{s} - 145 \text{ ns}$
