AURIX™ TC27x errata sheet

Marking/Step: ES-DC, DC

About this document

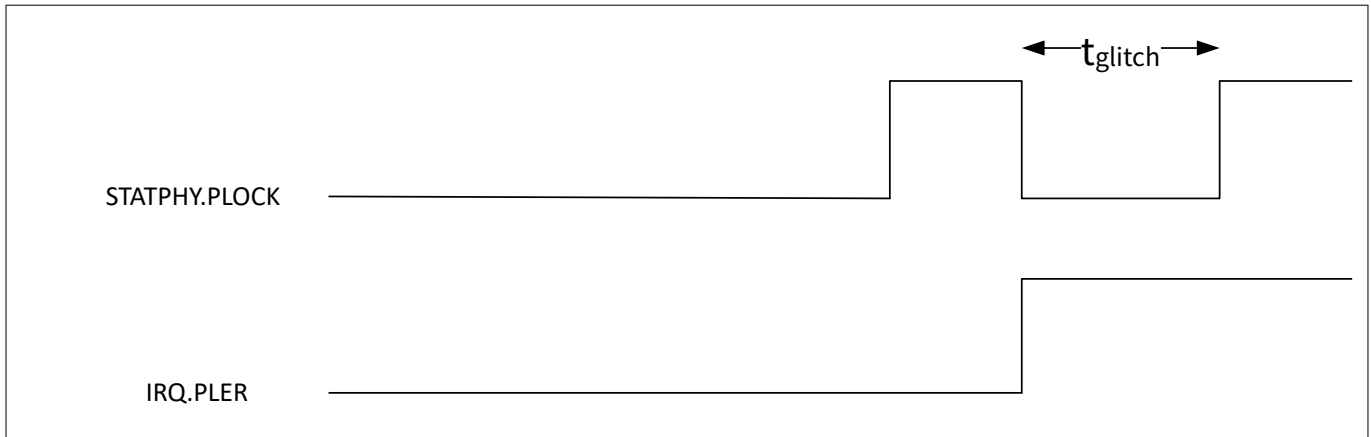
Figure 4 PLL Unlock Event Glitch

After STATPHY.PLOCK shows lock status, there is a possibility that the PLL is unlocked once for a short time (t_{glitch}) again at start-up phase, as shown in the figure below. This single unlock event as indicated by STATPHY.PLOCK recovers back to lock status without any software intervention.

The minimum time duration of t_{glitch} is 224 cycles of the PLL reference clock (RefClk). An example of minimum t_{glitch} duration for RefClk with 20 MHz and 10 MHz is shown in the table below.

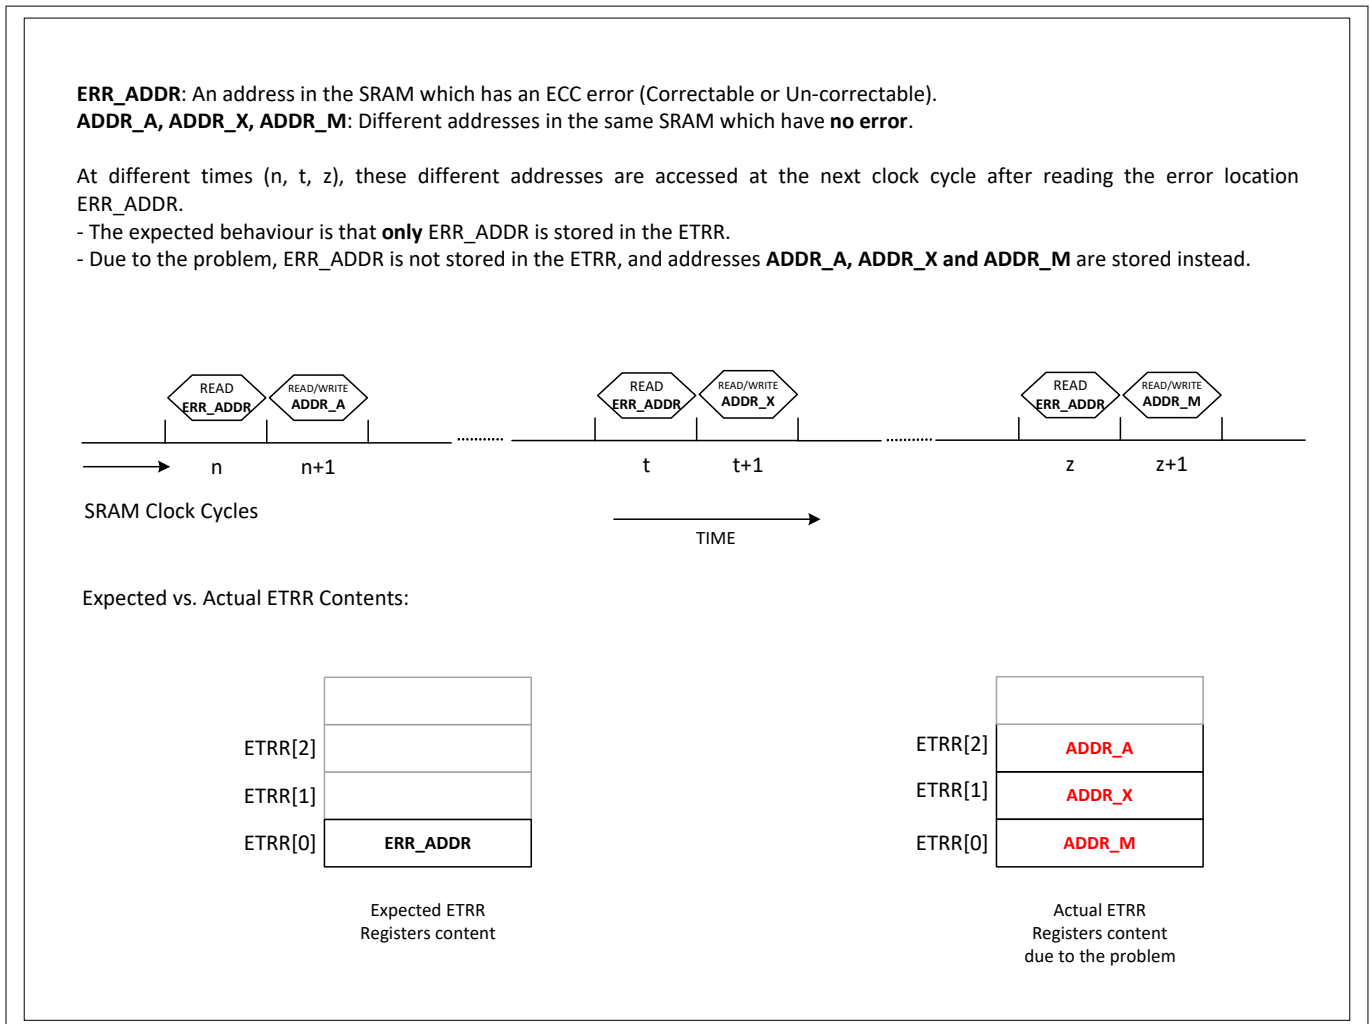
Figure 5 Example sequence showing how registers ETRRx may be filled with “Error Free” addresses

When such a consecutive access sequence (read from ERR_ADDR followed by read/write of different address(es)) happens multiple times, registers ETRRx are filled with addresses that have actually no error – and the SRAM address which actually has an error is not stored indeed. Figure 5 shows such an example scenario.

The consequence of the scenario explained in Figure 5 is that a single error in the SRAM – example just one correctable error at a location ERR_ADDR – can result in registers ETRRx getting filled with fault-free address, and thus potentially even triggering an ETRR overflow.

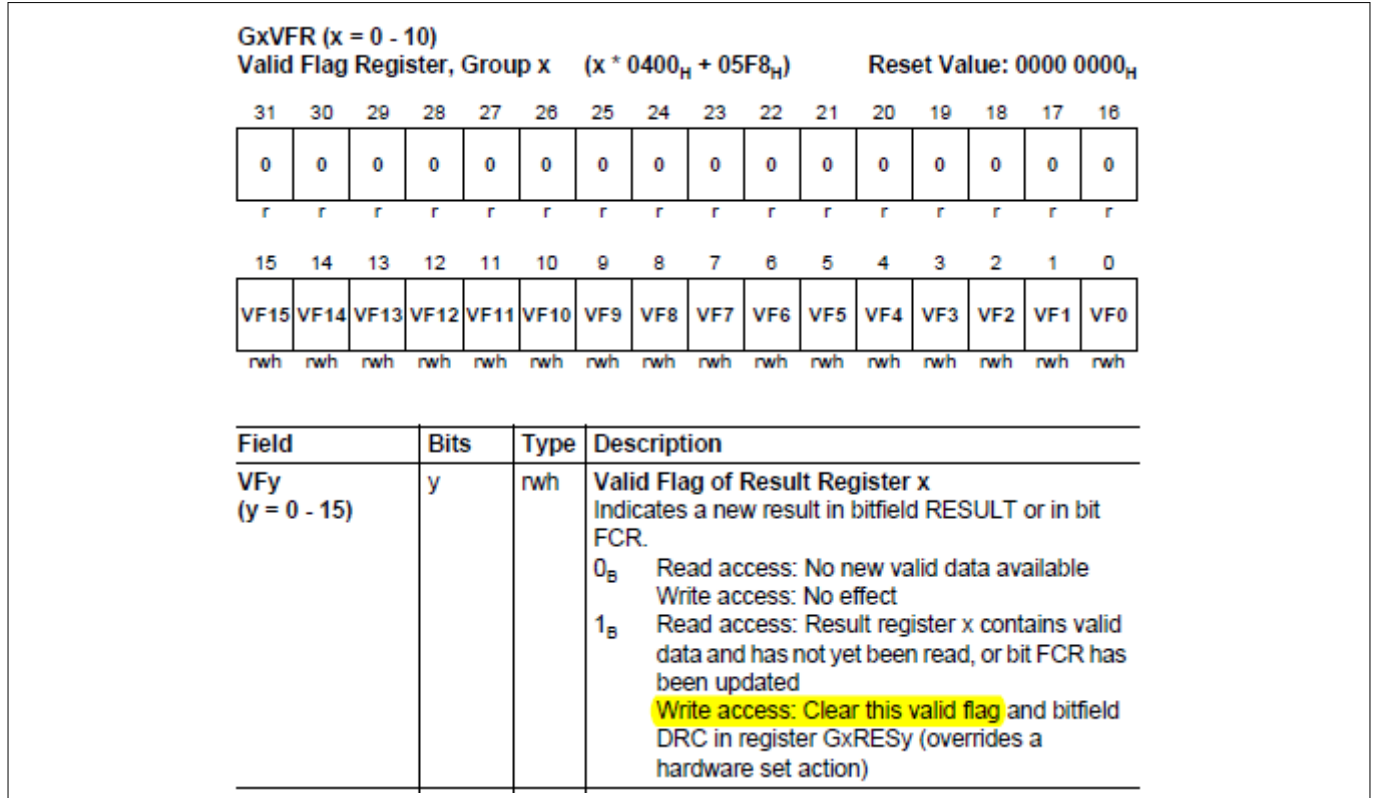
Figure 8 Register GxVFR in the VADC Module of TC2xx Devices

The bits in the GxVFR register have to be written with 1_B to clear a valid flag VFy indicating a valid result. Assuming VFy = 1_B, if one of the RMW instructions listed above is used, the write to VFy would never happen since VFy is already set to 1_B. This means that the next read of VFy may lead to incorrect conclusions by software.

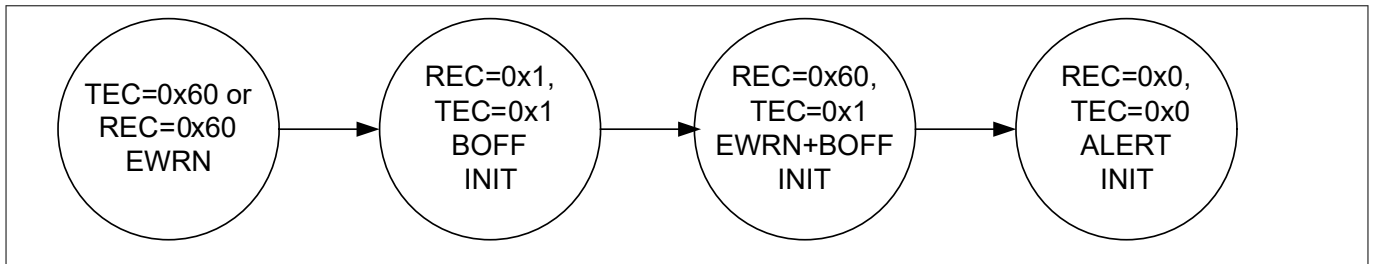
Figure 12 Alert Interrupt Behavior in case of Bus-Off

When the threshold for error warning (EWRN) is reached (default value of Error Warning Level EWRN = 0x60), then the EWRN interrupt is issued. The bus-off (BOFF) status is reached if TEC > 255 according to CAN specification, changing the MultiCAN module with REC and TEC to the same value 0x1, setting the INIT bit to 1_B, and issuing the BOFF interrupt. The bus-off recovery phase starts automatically. Every time an idle time is seen, REC is incremented. If REC = 0x60, a combined status EWRN+BOFF is reached. The corresponding interrupt can also be seen as a pre-warning interrupt, that the bus-off recovery phase will be finished soon. When the bus-off recovery phase has finished (128 times idle time have been seen on the bus), EWRN and BOFF are cleared, the ALERT interrupt bit is set and the INIT bit is still set.

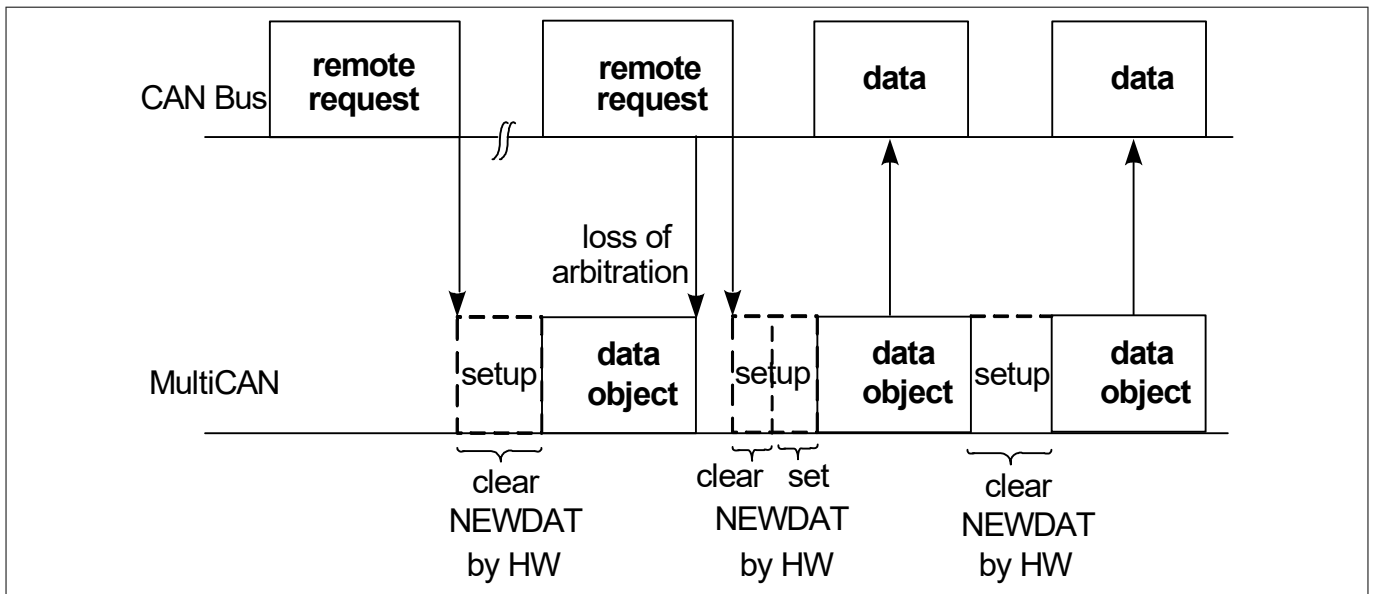
Figure 13 Loss of Arbitration

When the appropriate message object (data frame) triggered by the first remote frame wins the arbitration, it will be sent out and NEWDAT is not reset. This leads to an additional data frame, that will be sent by this message object (clearing NEWDAT).

There will, however, not be more data frames than there are corresponding remote requests.

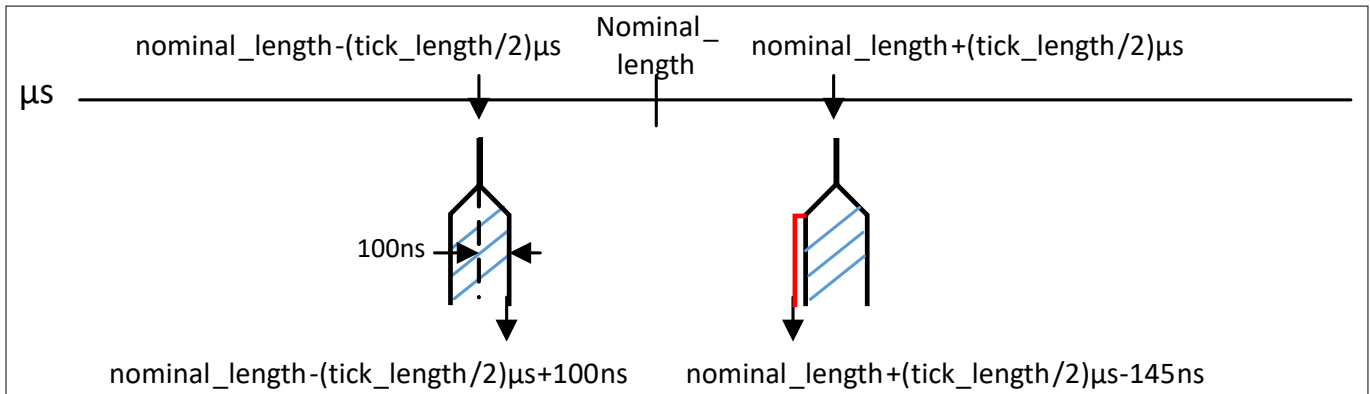
Figure 19 SENT Tolerance of this Design Step

- The lower border is $\text{nominal_value} - (\text{tick_length}/2) \mu\text{s} + 100 \text{ ns}$
- The upper border is $\text{nominal_value} + (\text{tick_length}/2) \mu\text{s} - 145 \text{ ns}$
