Device	XMC4400
Marking/Step	ES-AB, AB
Package	PG-LQFP-64/100

Document ID is **084/18**.

This “Errata Sheet” describes product deviations with respect to the user documentation listed below.

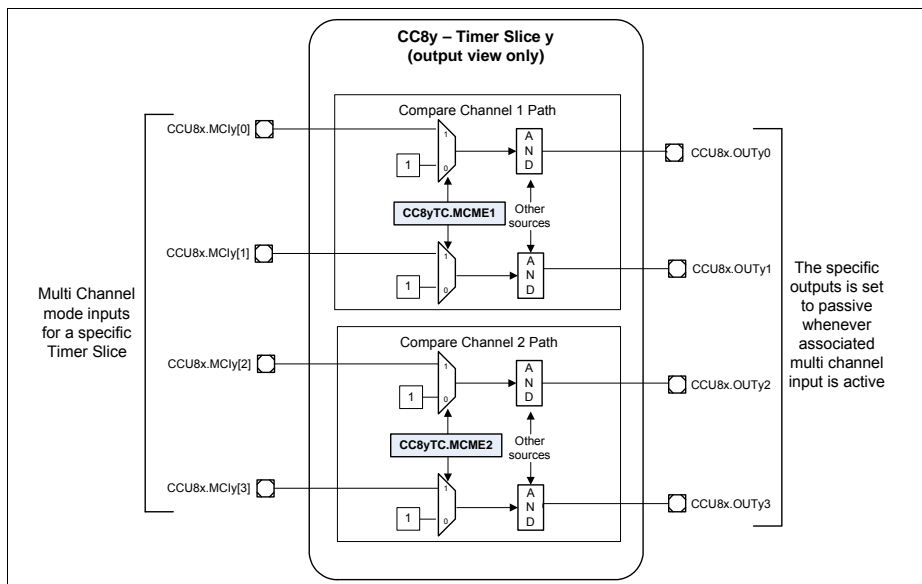
Figure 3 Multi Channel Mode diagram

The Multi Channel mode is normally used to modulate in parallel several PWM outputs (a complete CCU8 - up to 16 PWM signals can be modulated in parallel).

A normal use case is the parallel control of the PWM output for BLDC motor control. In Figure 2, we can see the Multi Channel Pattern being updated synchronously to the PWM signals. Whenever a multi channel input is active (in this case 0), the specific output is set into passive level (the level in which the external switch is OFF).

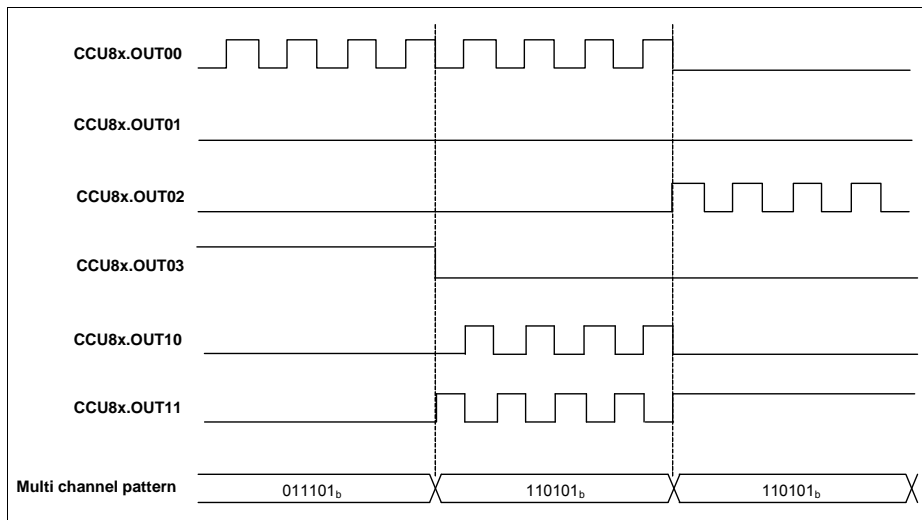
Figure 4 Multi Channel Mode applied to several CCU8 outputs

A glitch is present at the PWM outputs whenever the dead time of the specific compare channel is enabled - CC8yDTC.DTE1 and/or CC8yDTC.DTE2 set to 1_B (each compare channel has a separate dead time function) - and the specific multi channel pattern for the channel is 01_B or 10_B.

The effect of this glitch can be seen in Figure 3. The duration of the PWM glitch has the same length has the dead time value programmed into the CC8yDC1R.DT1F field (for compare channel 1) or into the CC8yDC1R.DT2F.

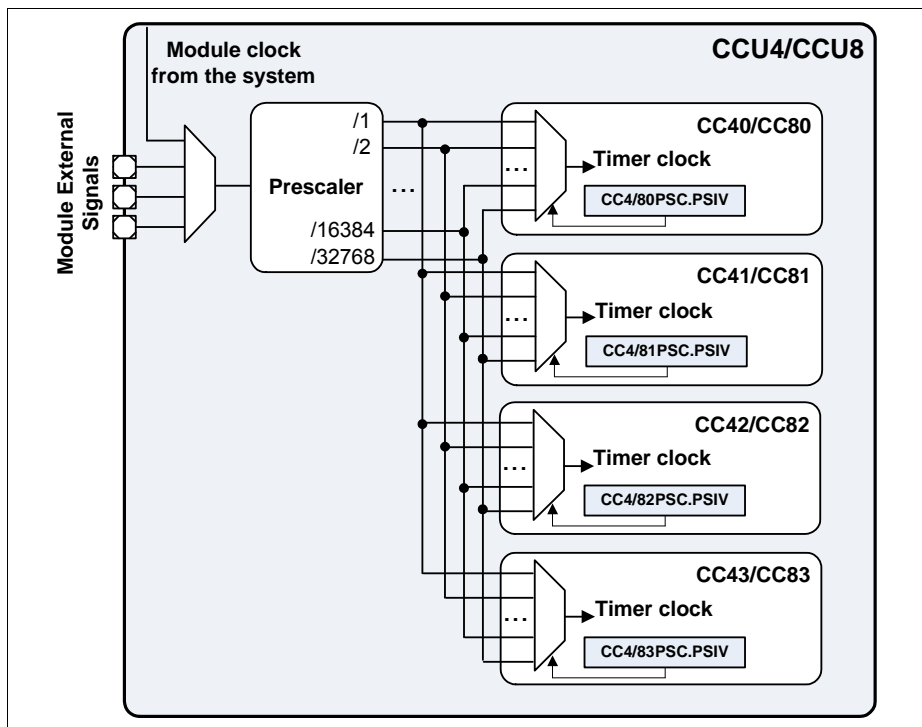
Figure 8 Clock Selection Diagram for CCU4/CCU8

This is only applicable if the Module Clock provided by the system (the normal default configuration and use case scenario) is not being used. In the case that the normal clock configured and programmed at system level is being used, there is not any type of constraints.

One should not also confuse the usage of an external signal as clock for the module with the usage of an external signal for counting. These two features are completely unrelated and there are not any dependencies between both.

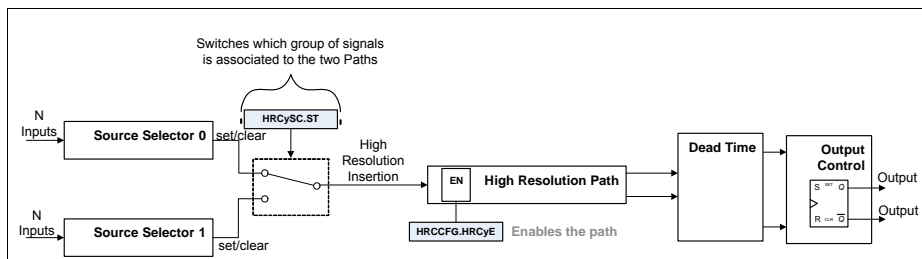
Figure 10 HRC with only one path enabled and two Source Selectors

This scenario where only one path is enabled but both Source Selectors are being used, and by being used is understood that signals are being actively decoded from the Source Selectors (input signals for the Source Selectors are being updated) is depicted on [Figure 10](#) - in this example the High Resolution Path is the one being used.

In the above scenario, every time that the HRCyST.ST bitfield is 1_B , the Source Selector 1 is the one that has control over the PWM signal. Whenever the HRCyST.ST bitfield is 0_B is the Source Selector 0 that has control over the PWM signal.

If the described condition occurs, then the signal generated by Source Selector 1 is lost and the PWM signal is not handled properly - **Figure 11**.

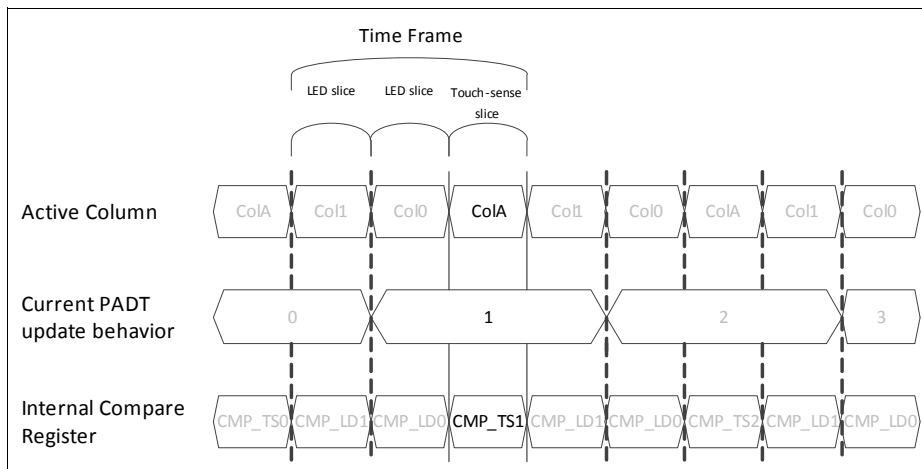
Figure 16 Internal Compare Register updated with correct compare register value with 2 LED columns enabled

If the number of LED columns enabled is 2 or more, the additional LED columns would provide some buffer time for the delay. So, at the start of a new touch-sense time slice, the update of PADT value would have taken place. Hence, the current active PADT compare register value is updated to the internal compare register (Figure 16).

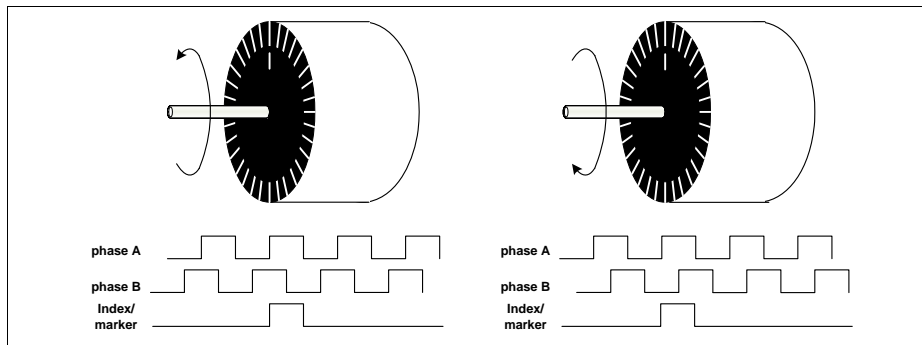
Figure 18 Rotary Encoder outputs - Phase A, Phase B and Index

Each POSIF module can be used as an input interface for a Rotary Encoder. It is possible to configure the POSIF module to decode 3 different signals: Phase A, Phase B (these two signals are 90° out of phase) and Index. The index signal is normally understood as the marker for the zero position of the motor Figure 1.

When the index signal is smaller than 1/2 of the tick period, the POSIF module is not able to decode this signal properly, Figure 2 - notice that the reference edge of the index generation in this figure is the falling of Phase B, nevertheless this is an example and depending on the encoder type, this edge may be one of the other three.

To make usage of the Index signal, when the length of this signal is less than 1/2 of the tick period, one should connect it directly to the specific counter/timer. This connection should be done at port level of the device (e.g. connecting the device port to the specific Timer/Counter(s)), Figure 3.
