AURIX™ TC39x errata sheet

Marking/Step: (E)ES-BD, BD

10520AERRA

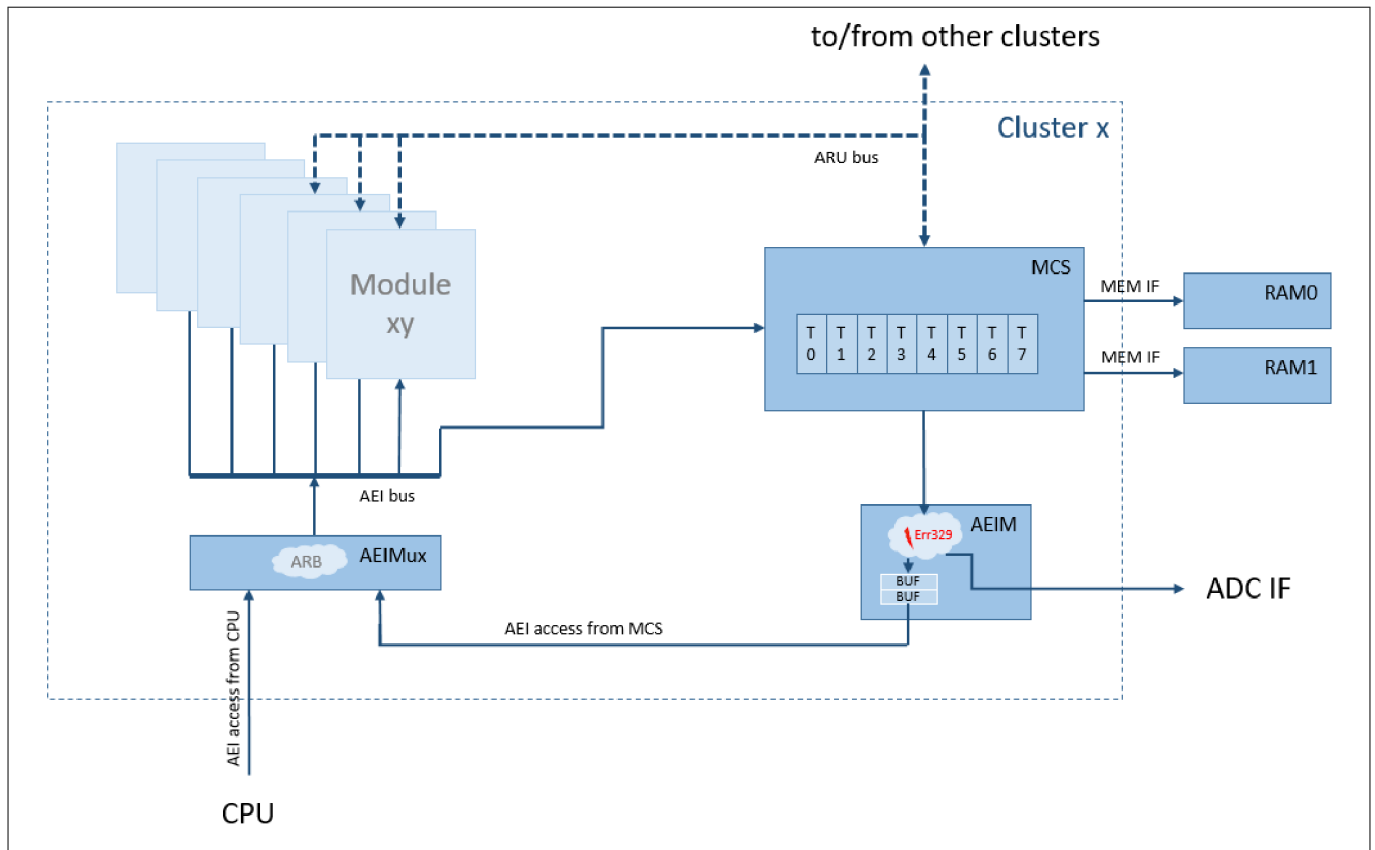
Figure 5 Cluster-internal AEI network

Problem GTM_AI.329 is related to a potential incorrect handling of MCS access requests to the AEI bus at the AEIM entry stage in case that one AEIM buffer is already filled. If in such a case a new access request from MCS enters the AEIM logic during a very specific time window (related to progress on the AEI bus), the AEIM logic might signalize incorrect parameters back to MCS that could result in incorrect data, the loss of data or a repetitive execution of MCS accesses to AEI.
