AURIX™ TC23x errata sheet

Marking/Step: ES-AC, AC

About this document

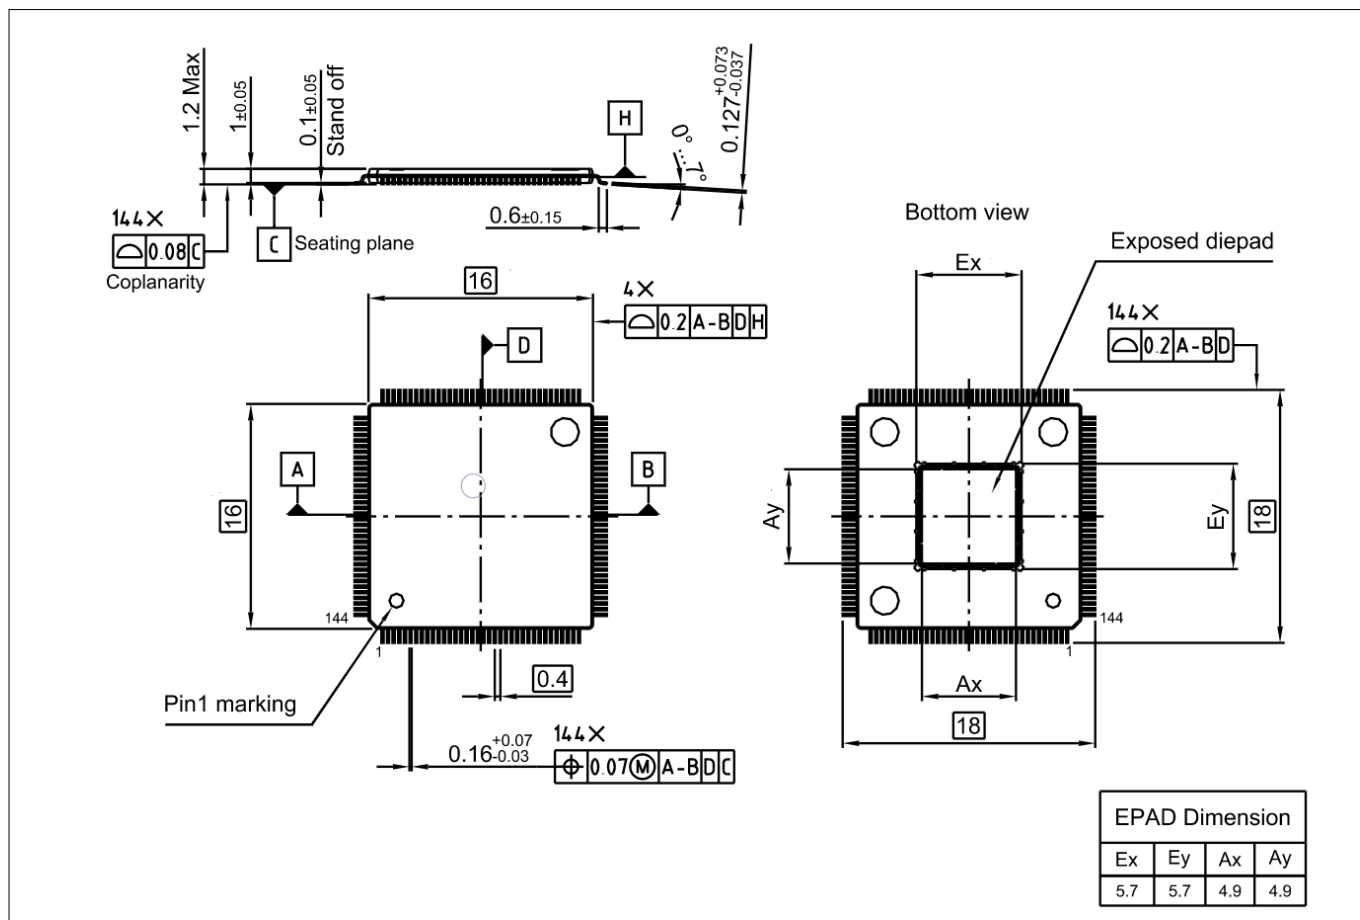
Figure 12 Package Outlines TQFP-144 for TC23x

Note: For the exposed pad of the TQFP-144 package of the TC23x, structural corner protrusions have to be considered for purposes of system design and integration with a maximum boundary of 6.2 mm.

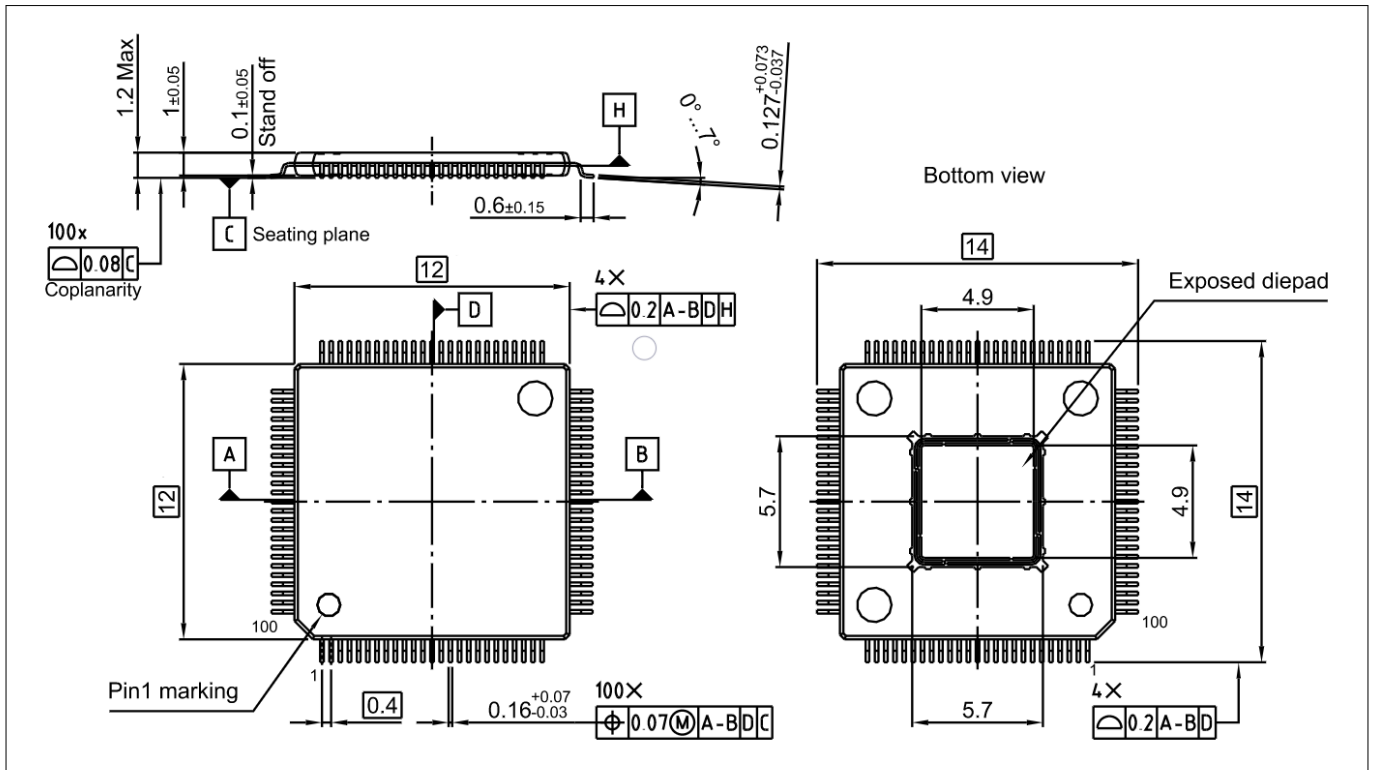
Figure 13 Package Outlines TQFP-100 for TC23x

Note: For the exposed pad of the TQFP-100 package of the TC23x, structural corner protrusions have to be considered for purposes of system design and integration with a maximum boundary of 6.3 mm.
