# AURIX™ TC26x errata sheet

**Marking/Step: ES-BC, BC**

10504AERRA

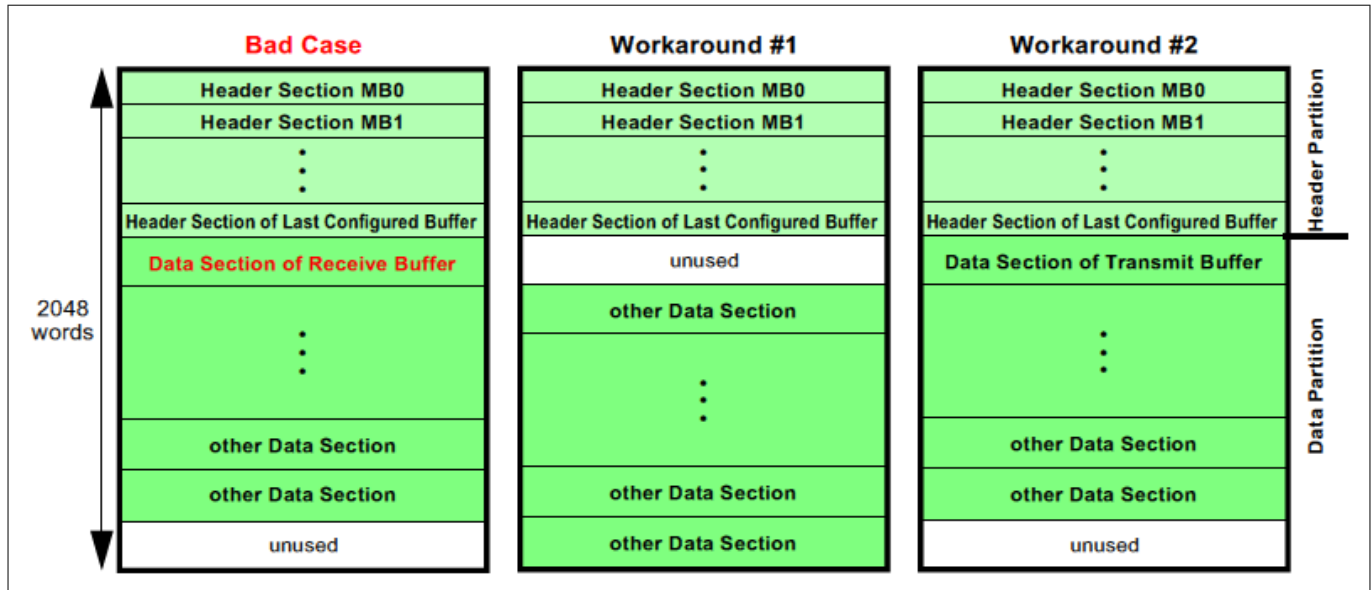
Figure 3 Message RAM configurations

The erratum is limited to the case when (see Figure 3 “Bad Case”):

Ensure that the Data Section directly following the Header Partition is assigned to a transmit buffer.

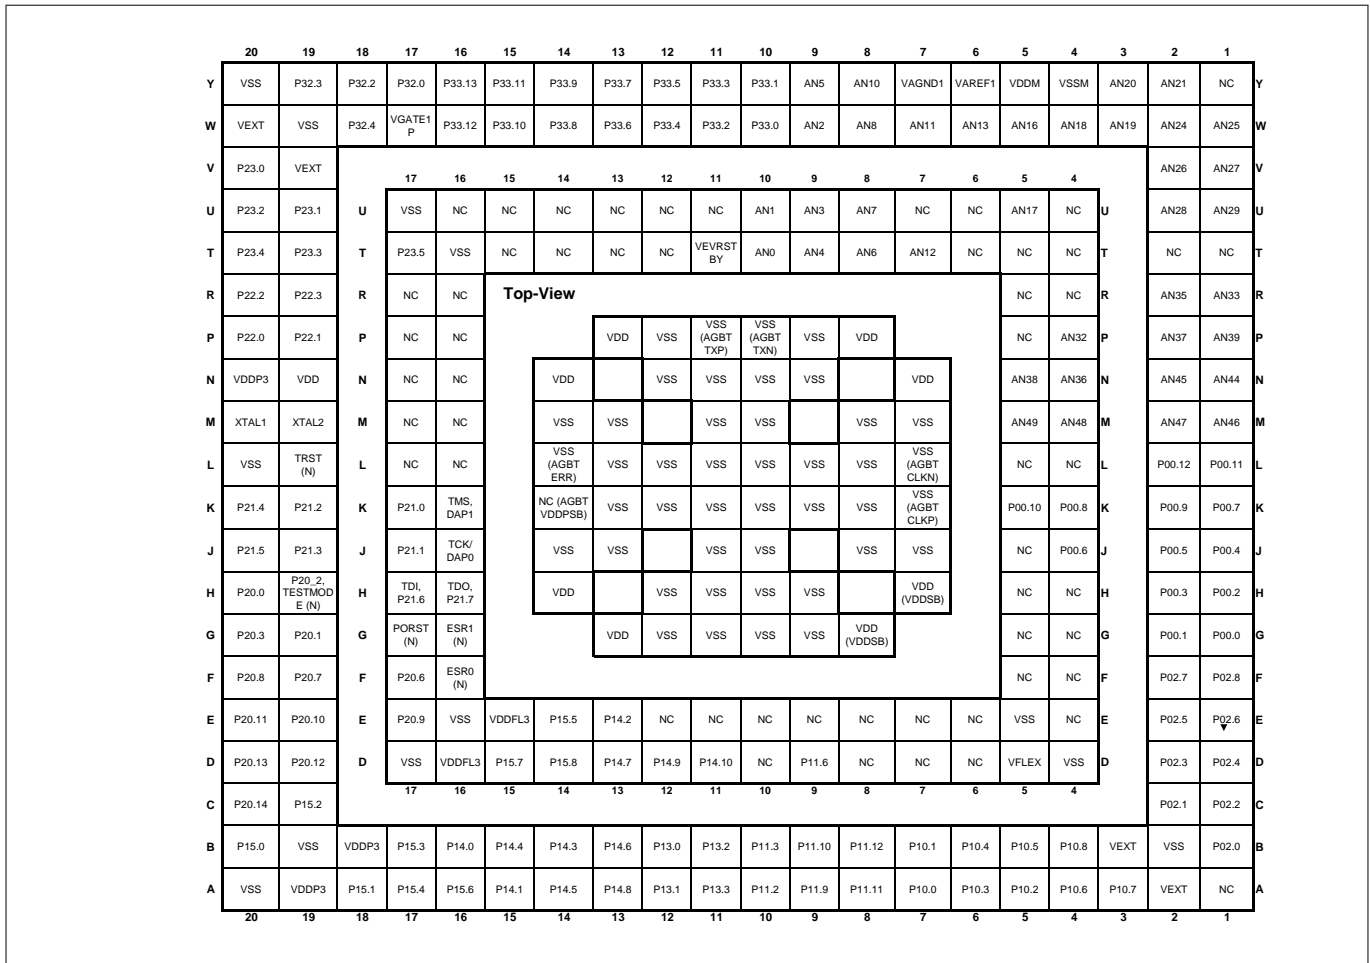
**Figure 7 TC267x Logic Symbol for the Package Variant BGA292**

The correct version of “TC267x Logic Symbol for the Package Variant BGA292” is shown in the following [Figure 7](#).

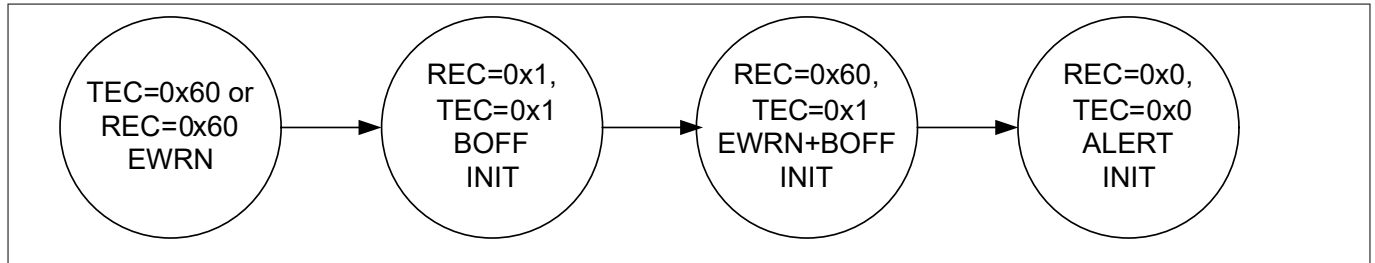
**Figure 12 Alert Interrupt Behavior in case of Bus-Off**

The MultiCAN module shows the following behavior in case of a bus-off status:

When the threshold for error warning (EWRN) is reached (default value of Error Warning Level EWRN = 0x60), then the EWRN interrupt is issued. The bus-off (BOFF) status is reached if TEC > 255 according to CAN specification, changing the MultiCAN module with REC and TEC to the same value 0x1, setting the INIT bit to 1<sub>B</sub>, and issuing the BOFF interrupt. The bus-off recovery phase starts automatically. Every time an idle time is seen, REC is incremented. If REC = 0x60, a combined status EWRN+BOFF is reached. The corresponding interrupt can also be seen as a pre-warning interrupt, that the bus-off recovery phase will be finished soon. When the bus-off recovery phase has finished (128 times idle time have been seen on the bus), EWRN and BOFF are cleared, the ALERT interrupt bit is set and the INIT bit is still set.

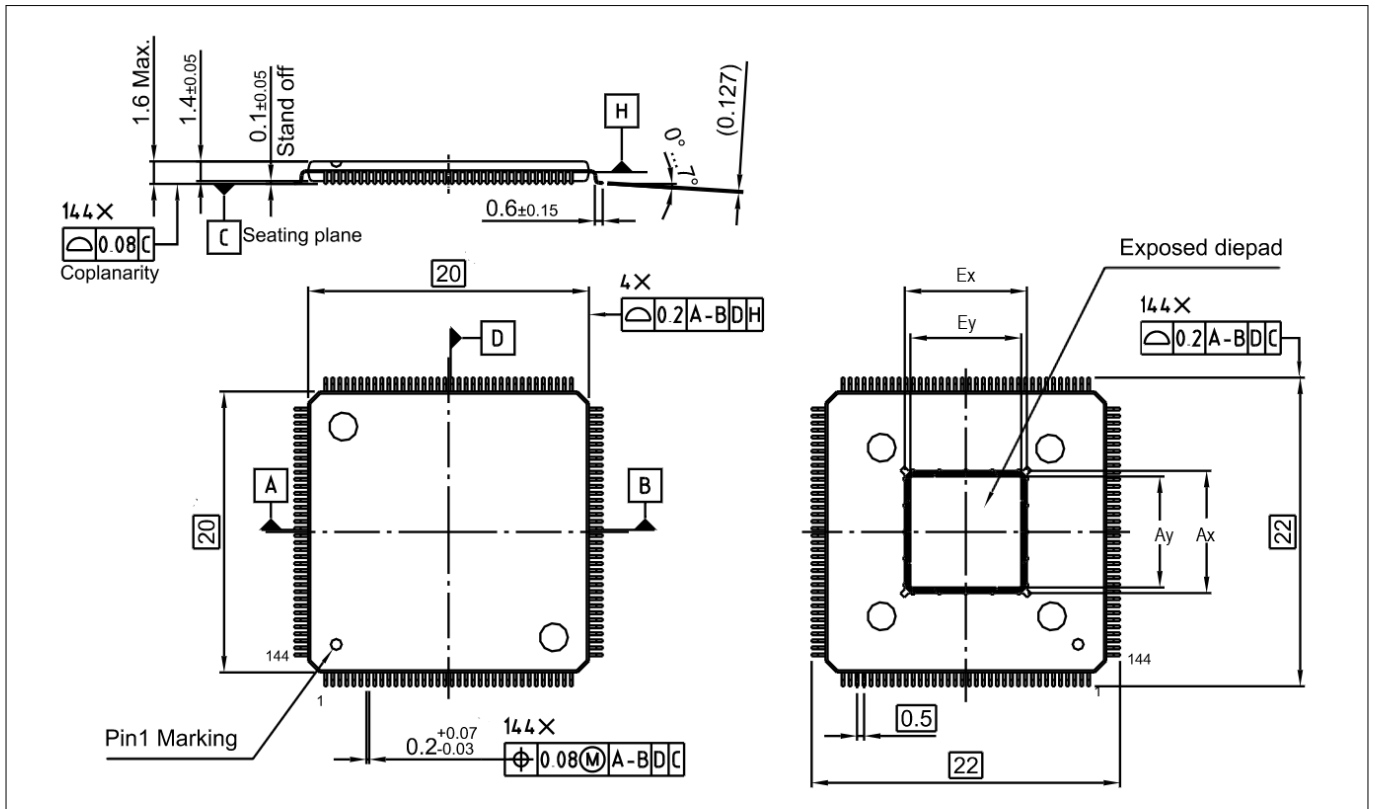
Figure 16 Package Outlines LQFP-144 for TC26x

**Note:** For the exposed diepad of the LQFP-144 package of the TC26x, structural corner protrusions have to be considered for purposes of system design and integration with a maximum boundary of 8.0 mm for TC26x devices with feature package D and DC (square Epad), and of 8.9 mm (in x direction) and 9.5 mm (in y direction) for TC26x devices with feature package DA.

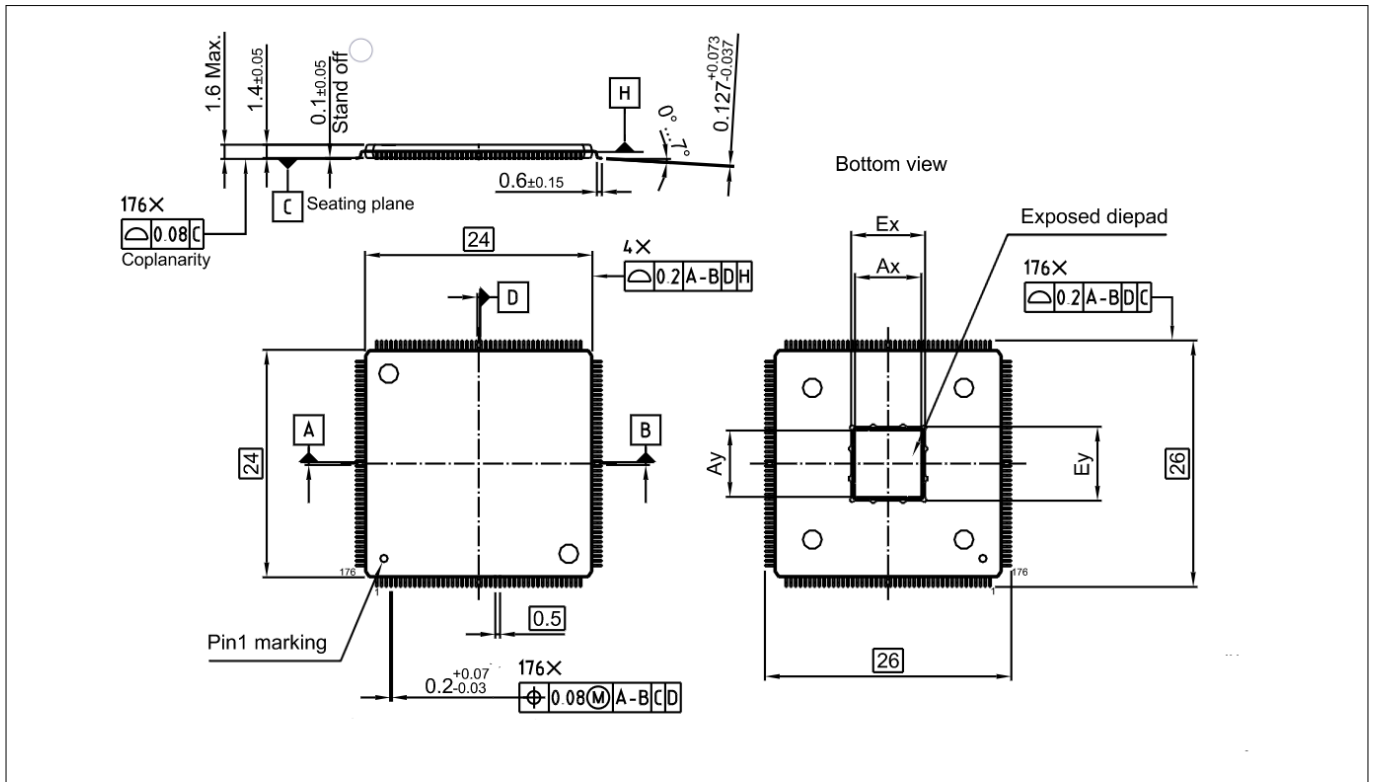
Figure 17 Package Outlines LQFP-176 for TC26x

**Note:** For the exposed diepad of the LQFP-176 package of the TC26x, structural corner protrusions have to be considered for purposes of system design and integration with a maximum boundary of 8.0 mm for TC26x devices with feature package D and DC (square Epad), and of 8.9 mm (in x direction) and 9.5 mm (in y direction) for TC26x devices with feature package DA.

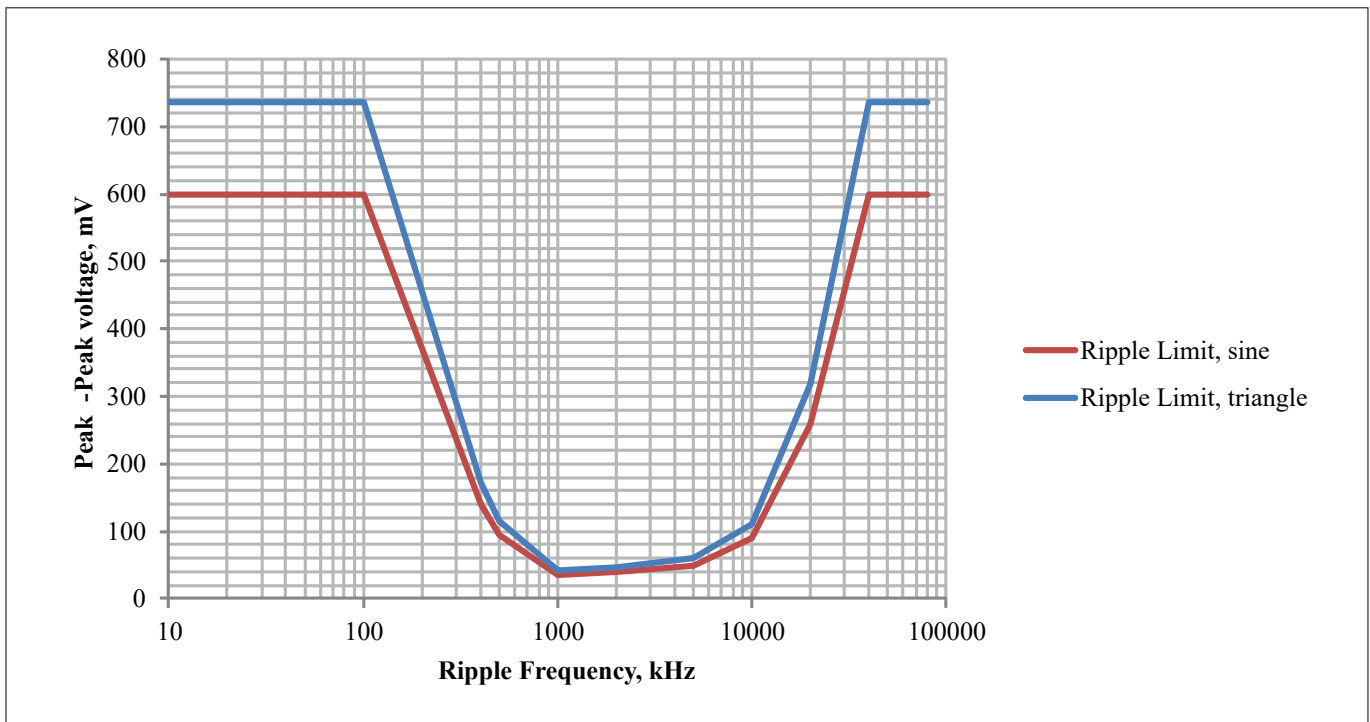
**Figure 18 Ripple Voltage vs. Frequency Characteristic**

The internal back-up clock is sensitive to specific power supply voltage disturbance/ripple caused by a voltage ripple intrinsic to DC-DC converters. Specific conditions such as insufficient filtering of the ripple may lead to improper behavior of the start-up scheme of the back-up clock, and thus stuck-at state during the start-up of the microcontroller until this condition is removed.

The acceptable voltage vs. frequency characteristic is portrayed below on the chart:

The diagram reflects acceptable ripple level during the cold start of the microcontroller at the respective VDDP3/VEXT/VEVRSB supply of the PMS subsystem, depending on the device and package type, as shown in the following table.
