AURIX™ TC27x errata sheet

Marking/Step: ES-DC, DC

About this document

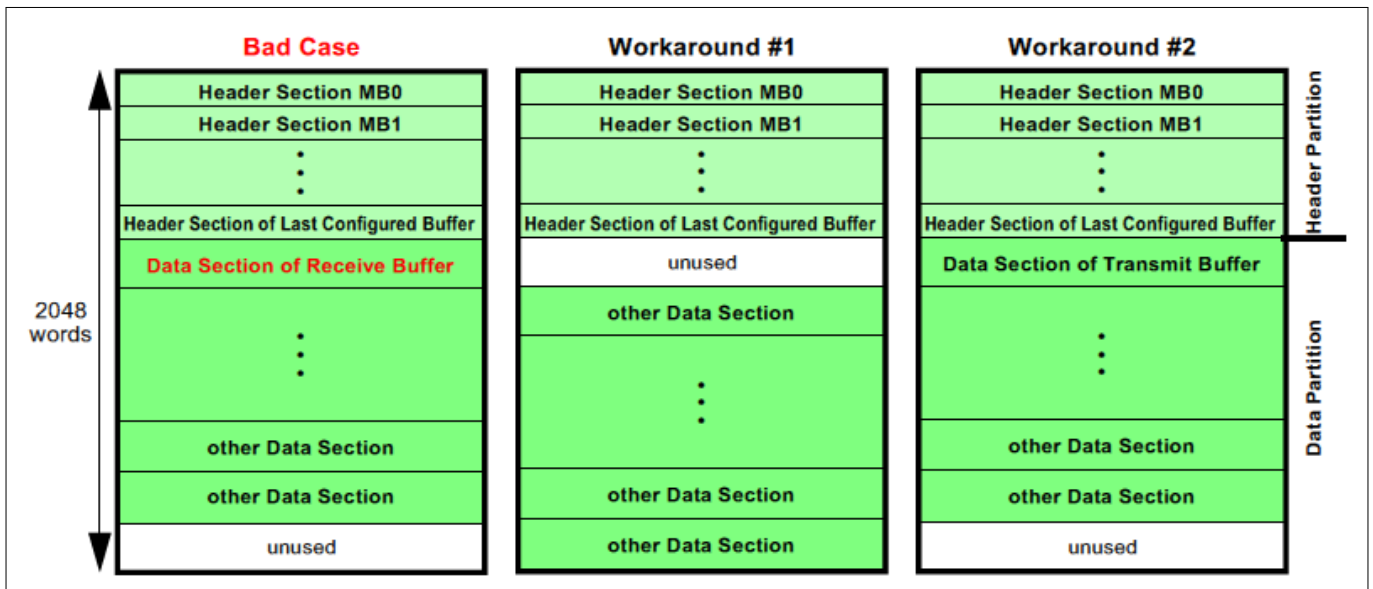
Figure 3 Message RAM configurations

The erratum is limited to the case when (see Figure 3 “Bad Case”):

Workaround 2

Ensure that the Data Section directly following the Header Partition is assigned to a transmit buffer.

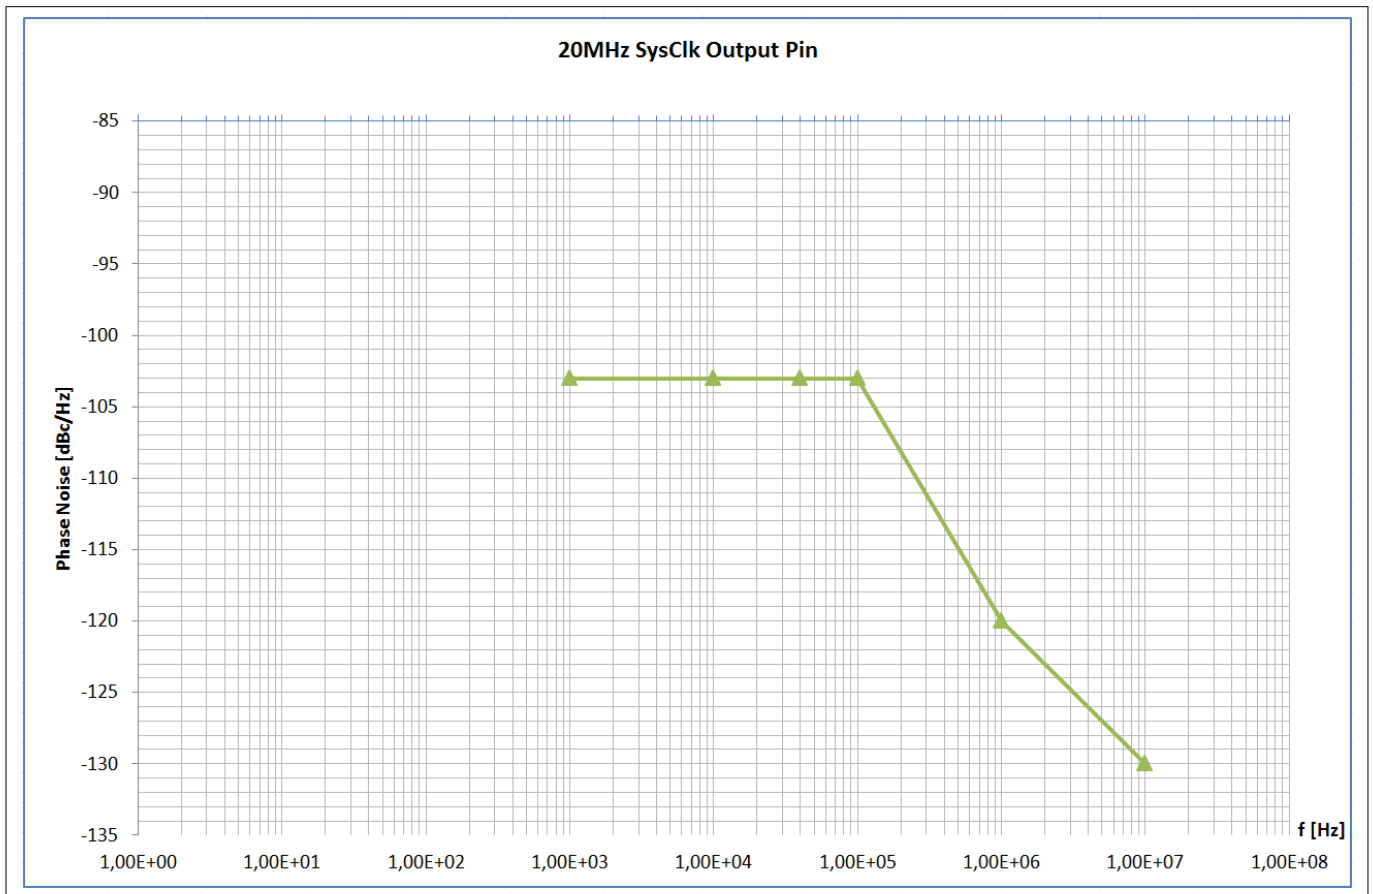
Nevertheless, such a target value on the random jitter of the SysClk signal is only an intermediate specification. The real target to be respected in order to assure BER_{20} of 10^{-12} is the total jitter of the link. The total jitter target is met. Consistently, measurements on the HSSL/HSCT communication channel using the SysClk signal with I_{PN} from above show that the ultimate target of $BER_{20} = 10^{-12}$ is met. In such a measurement setup, both the master and the slave are microcontrollers of the AURIX™ family.

The diagram below shows the phase noise density on the SysClk pin when no application pattern but only the HSSL/HSCT subsystem is running:

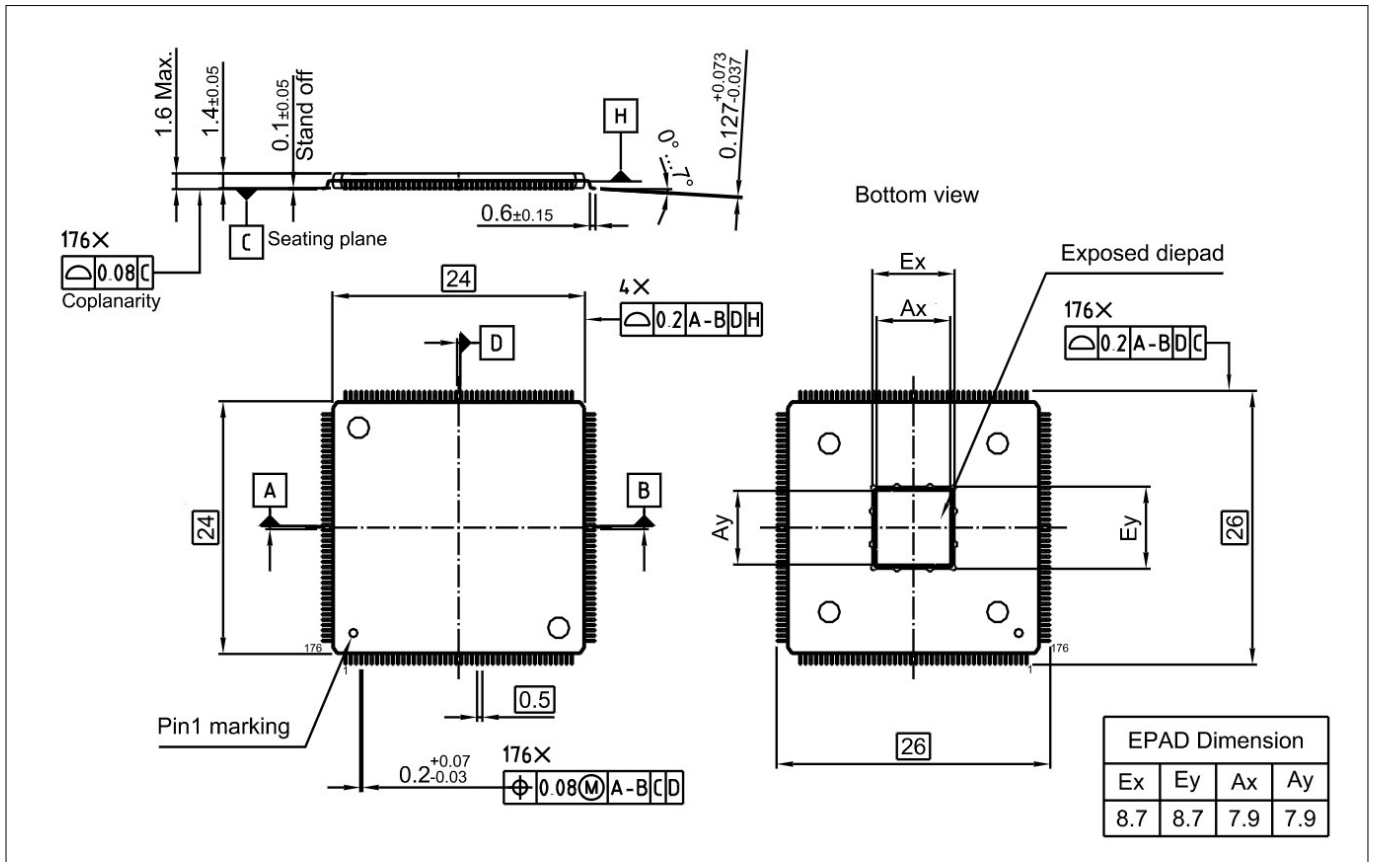
Figure 16 Package Outlines LQFP-176 for TC27x

Note: For the exposed pad of the LQFP-176 package of the TC27x, structural corner protrusions have to be considered for purposes of system design and integration with a maximum boundary of 9.4 mm.

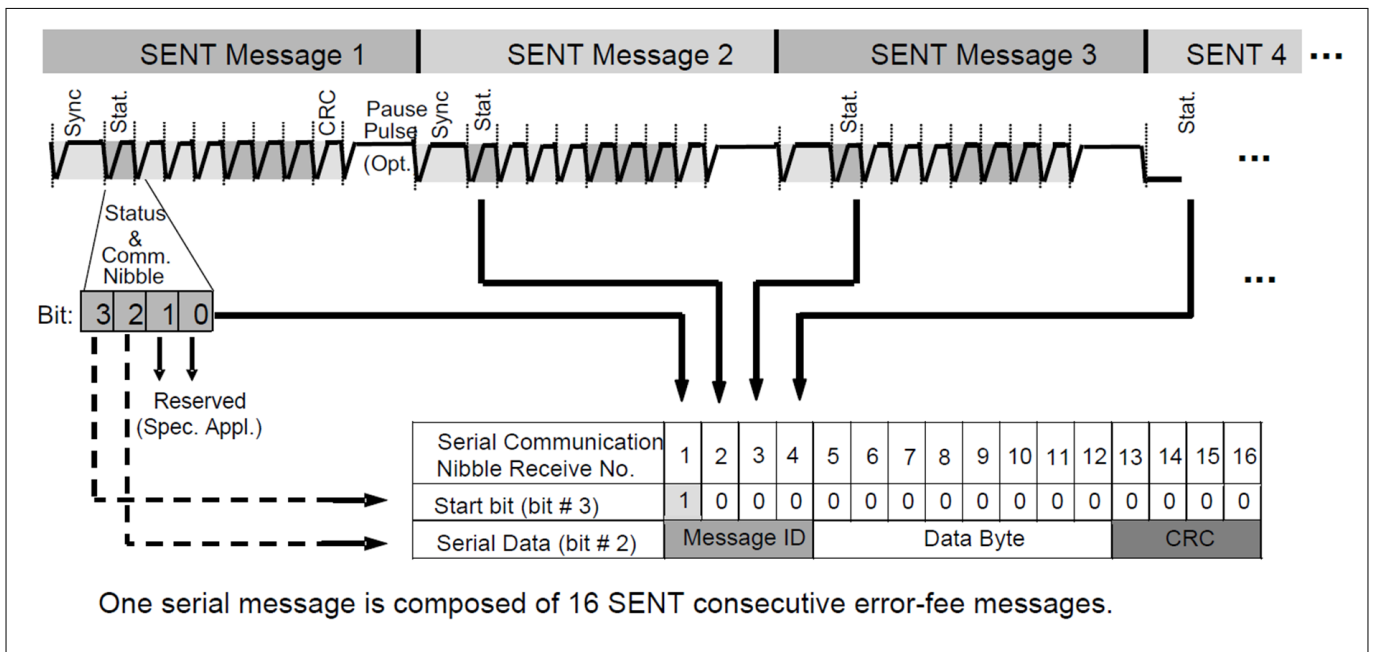
Figure 20 Short Serial Message, Serial Data Encoding over 16 messages

Figure 20 shows a corrected version of this figure.

Correction
